Jones Landslide, Pottsville, Arkansas – 2 ½ years of Monitoring

By
J. Michael Howard

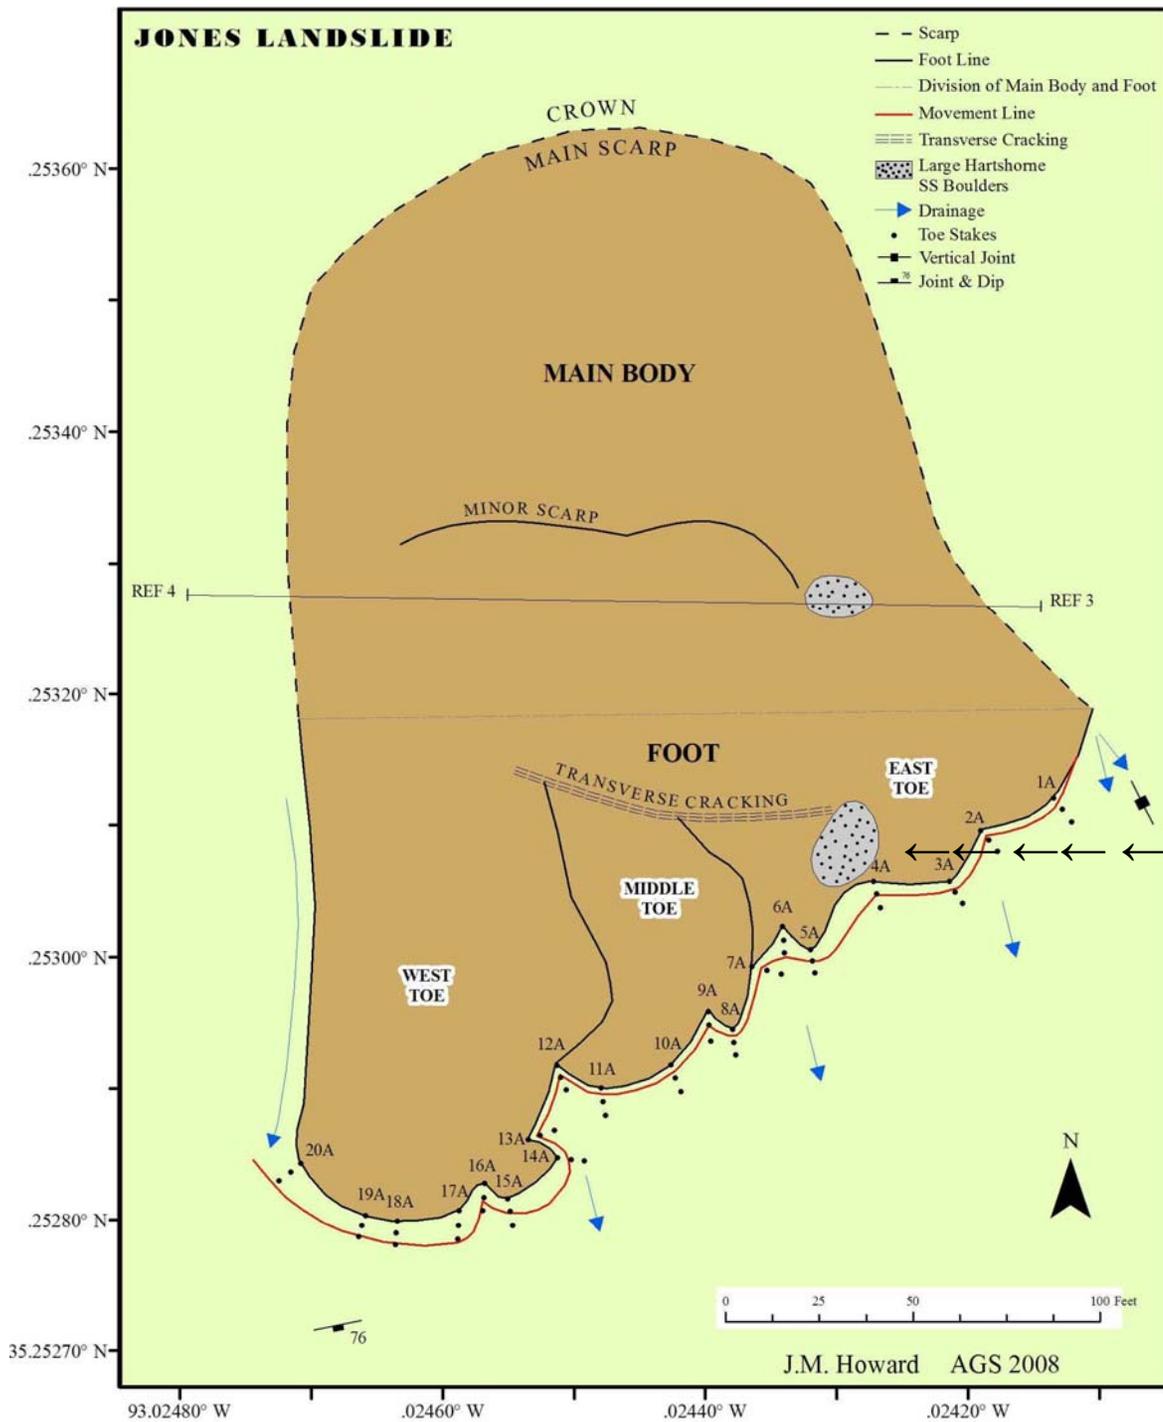
Map displaying major features of Jones Landslide

Crown

← Main scarp

Reclaimed area
that remains
stable

3 toed foot

Bottom of abandoned
shale pit

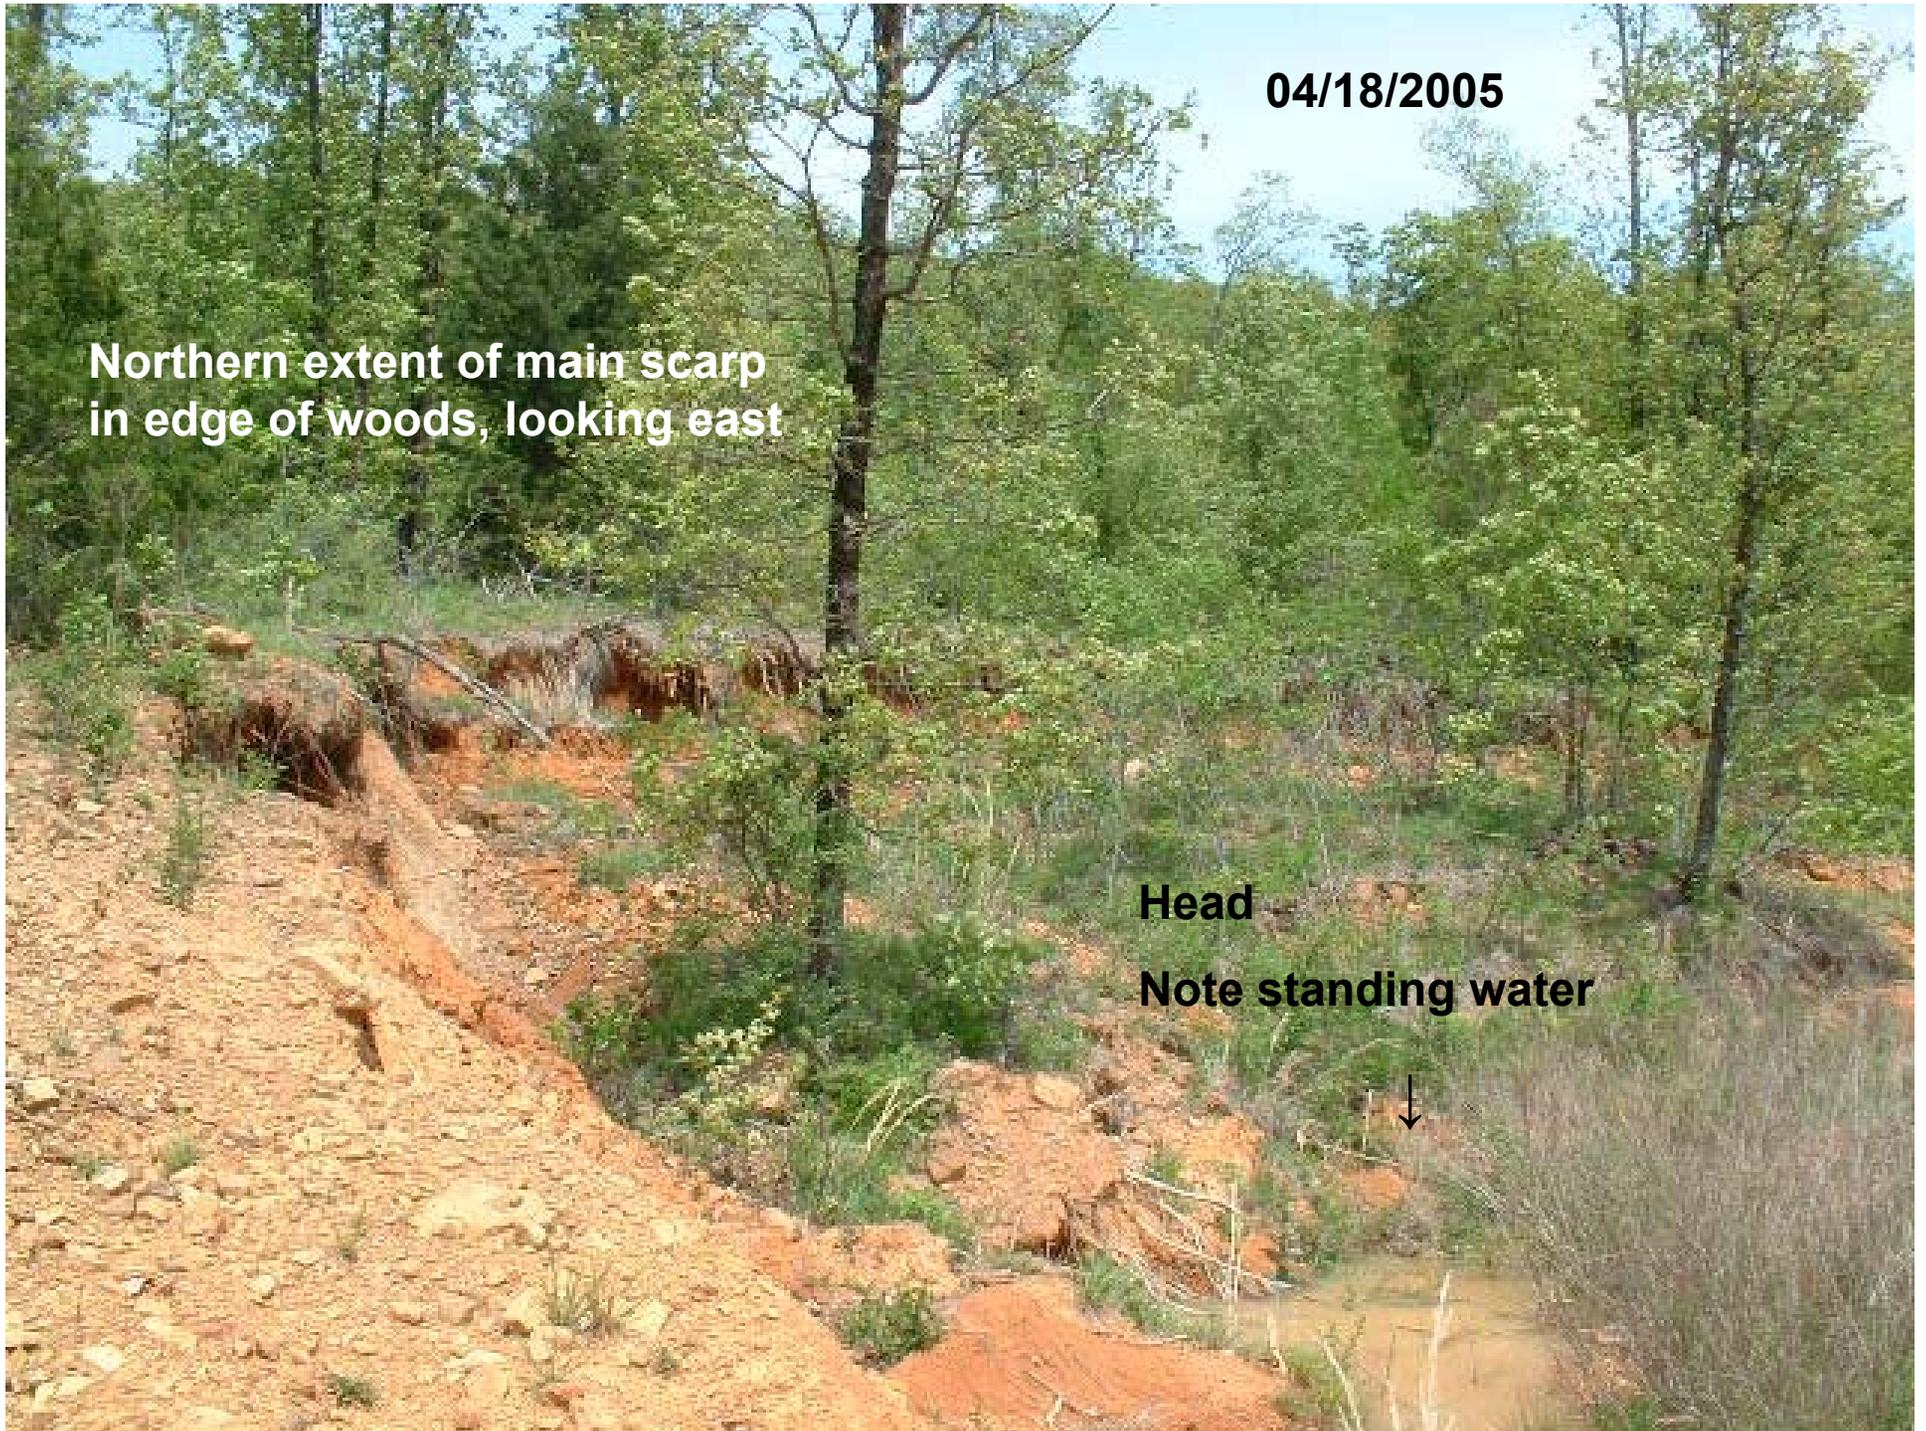
Northern extent of main scarp
in edge of woods, looking east

Note standing water

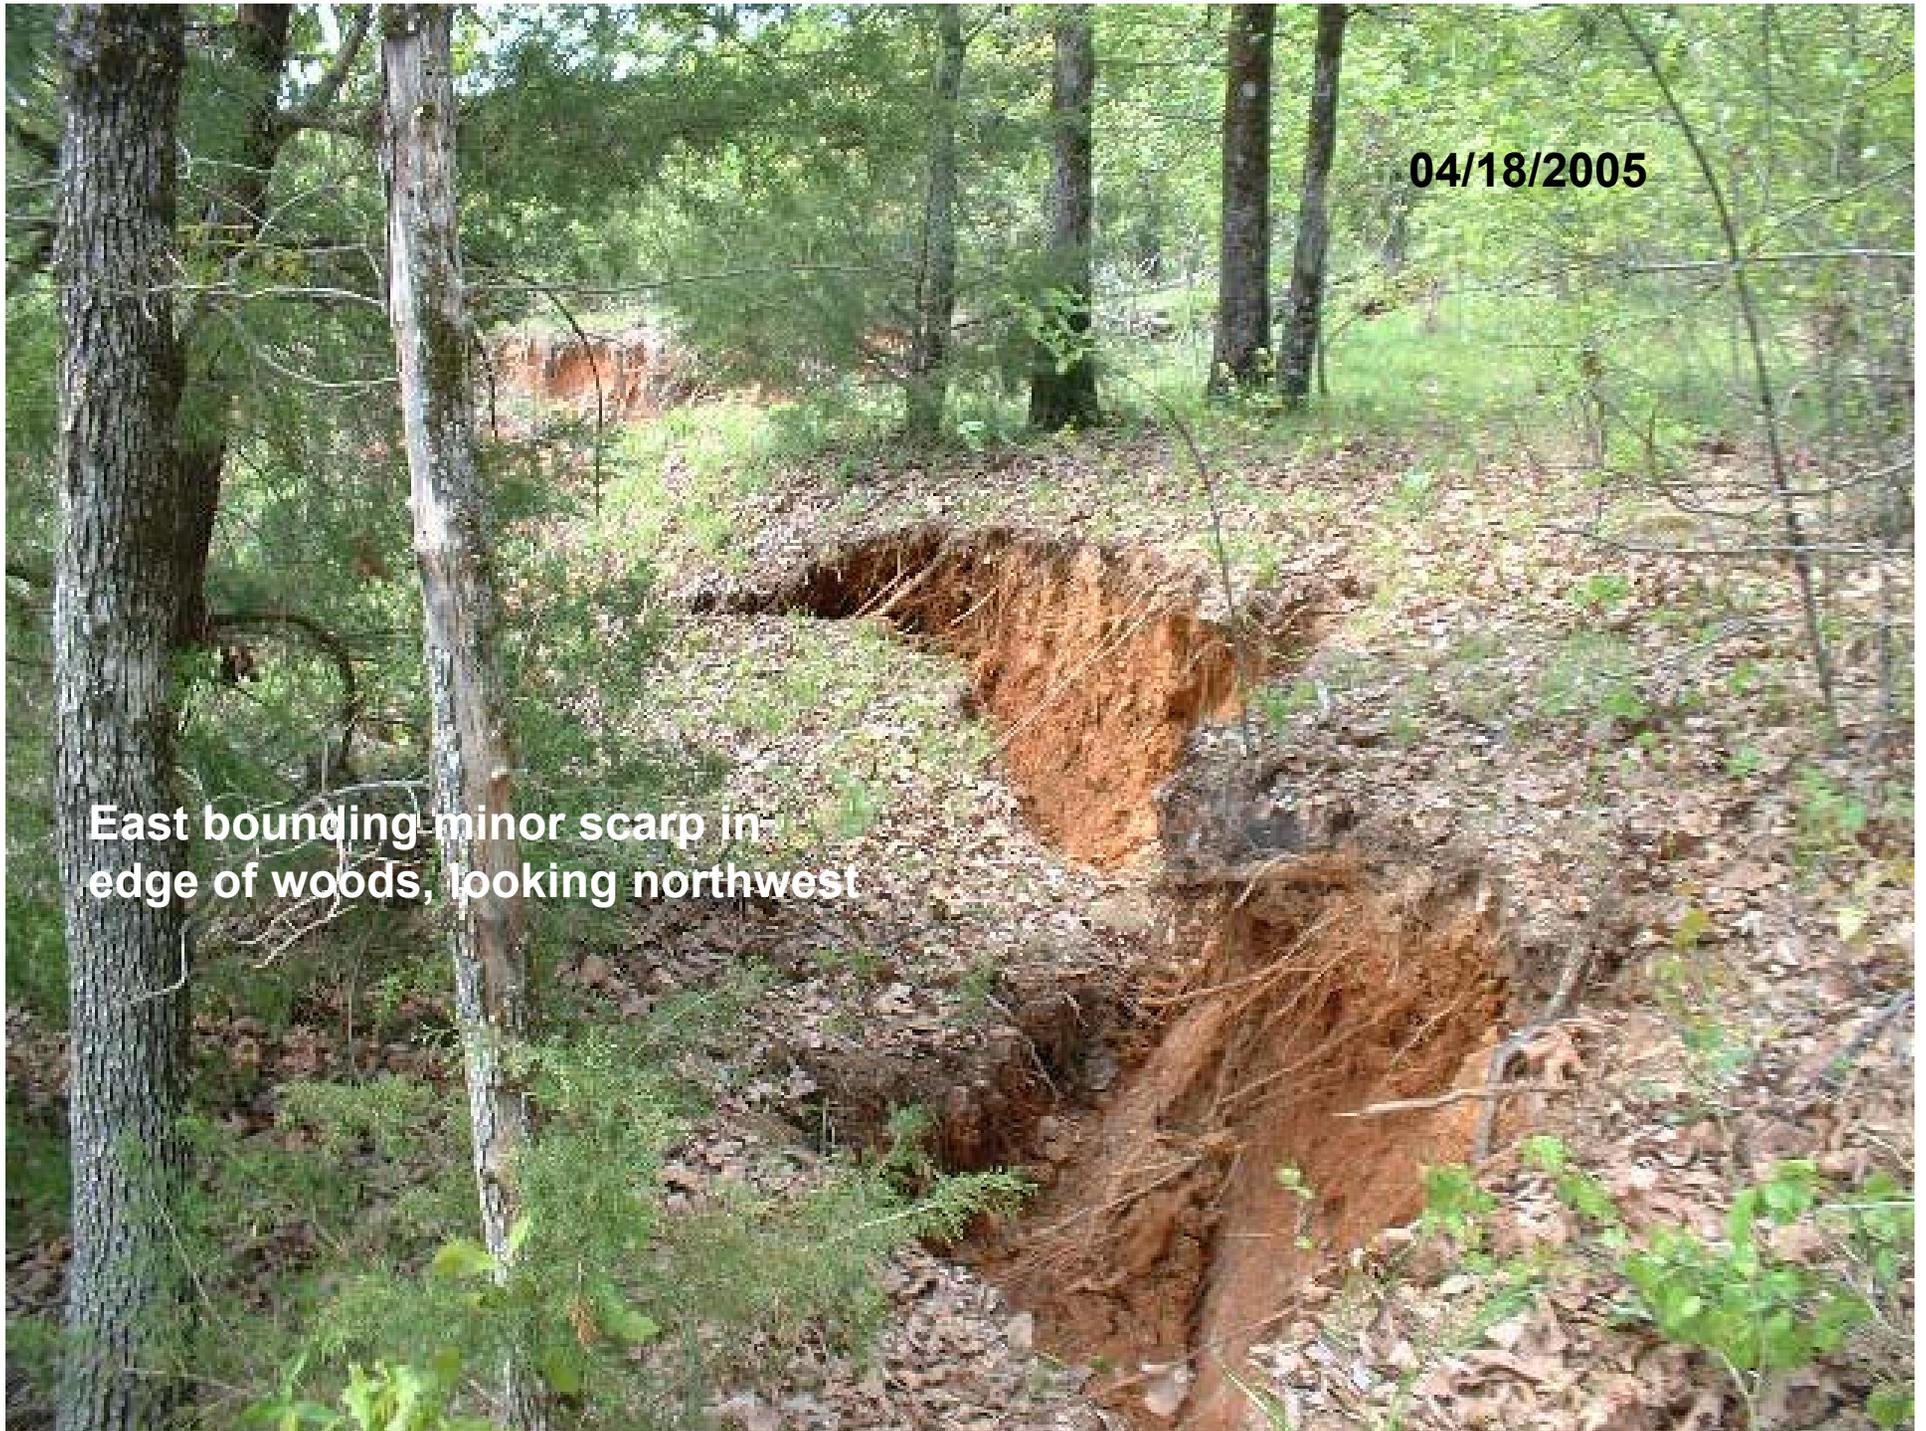
East bounding minor scarp in
edge of woods, looking northwest

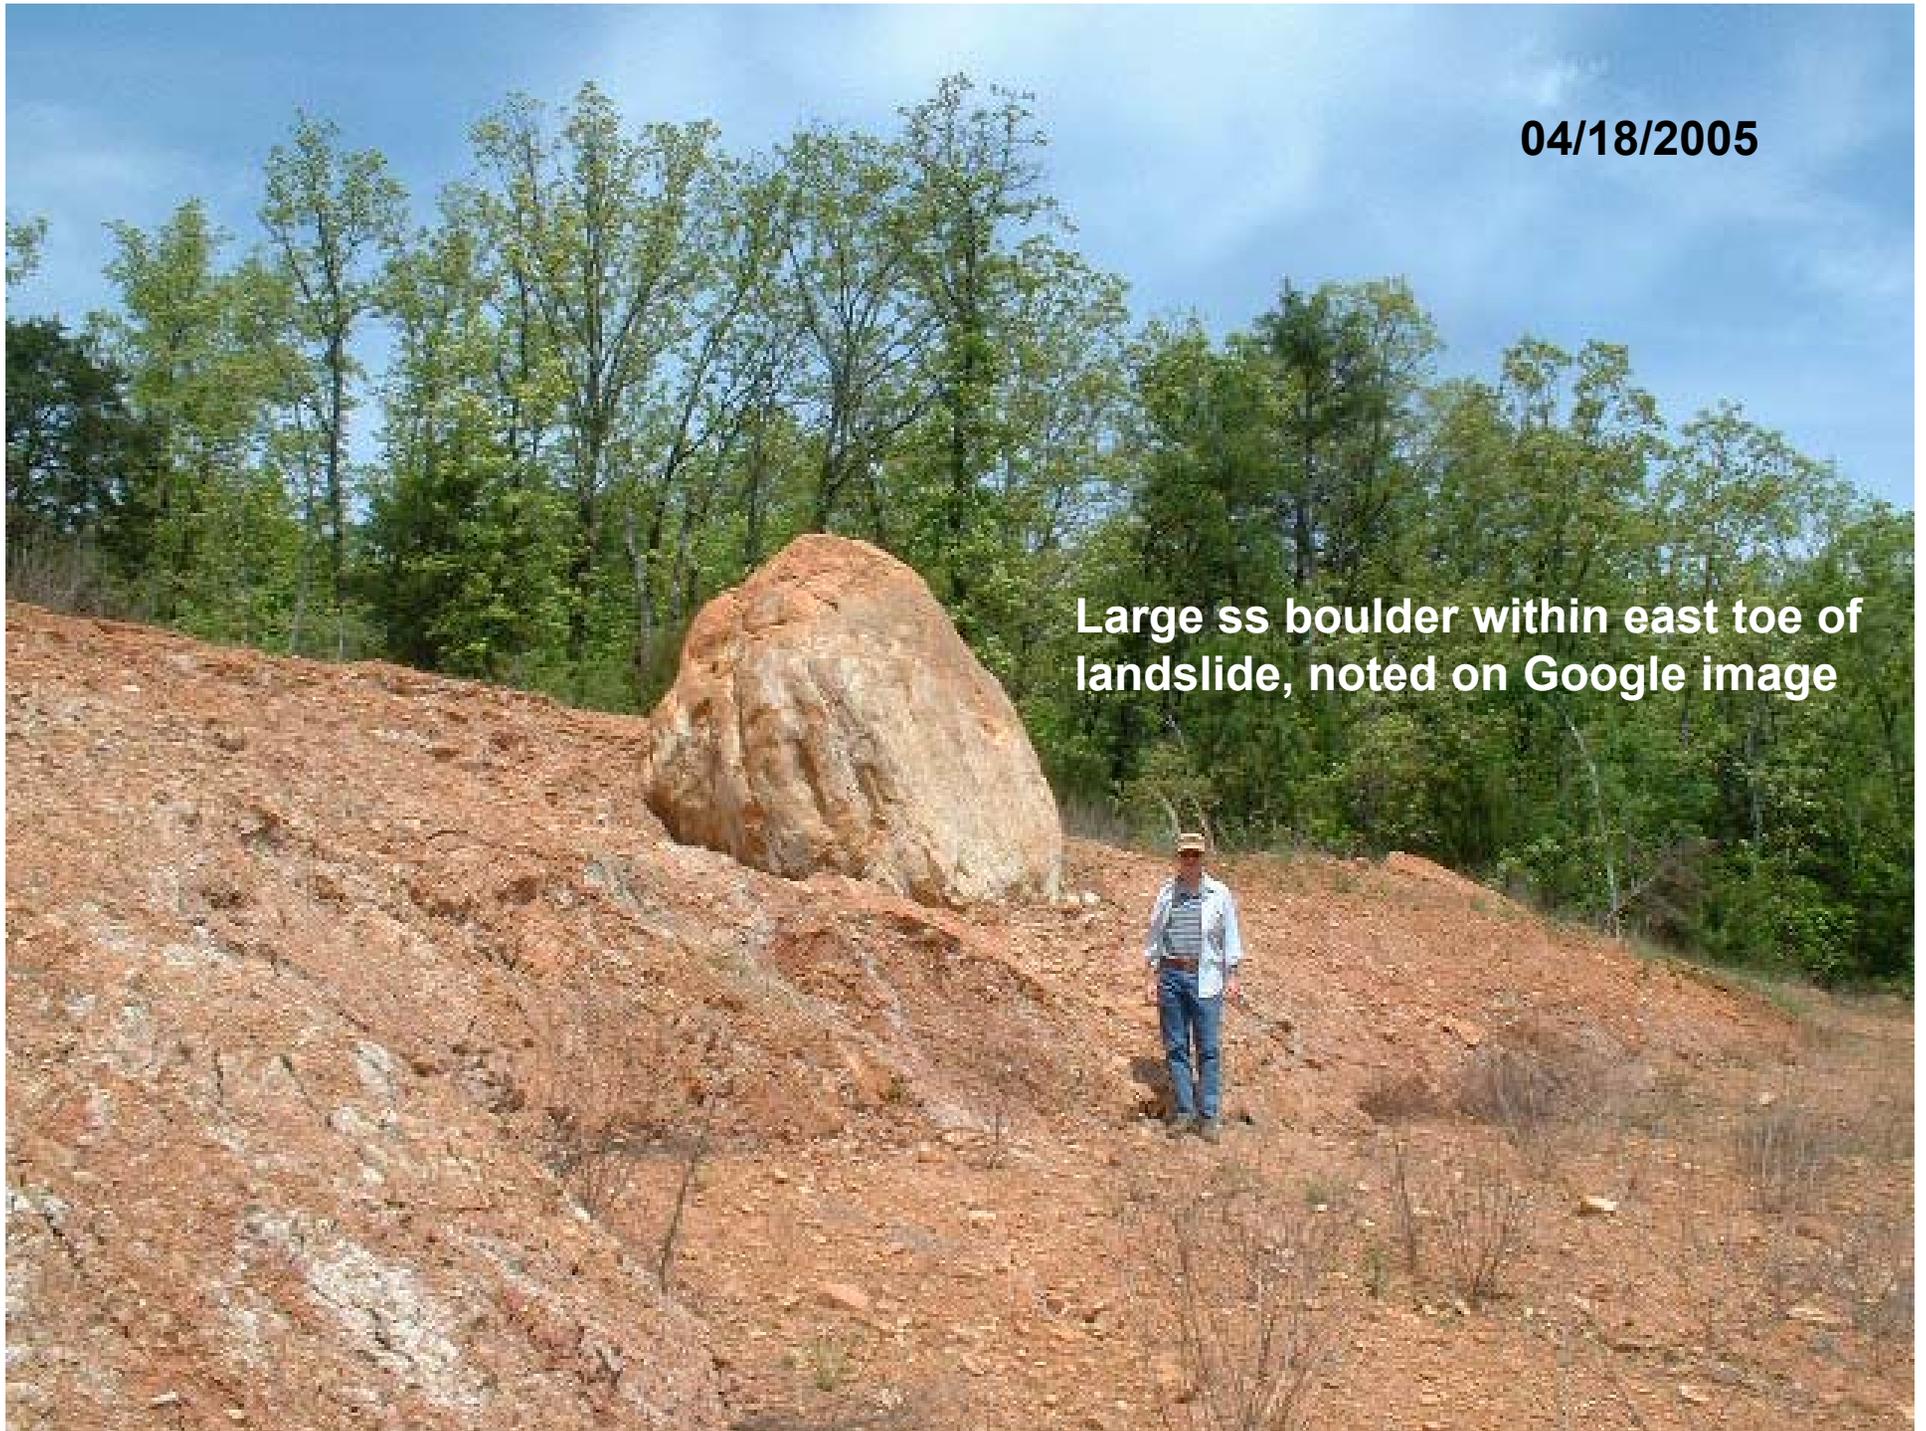
**Large ss boulder within east toe of
landslide, noted on Google image**

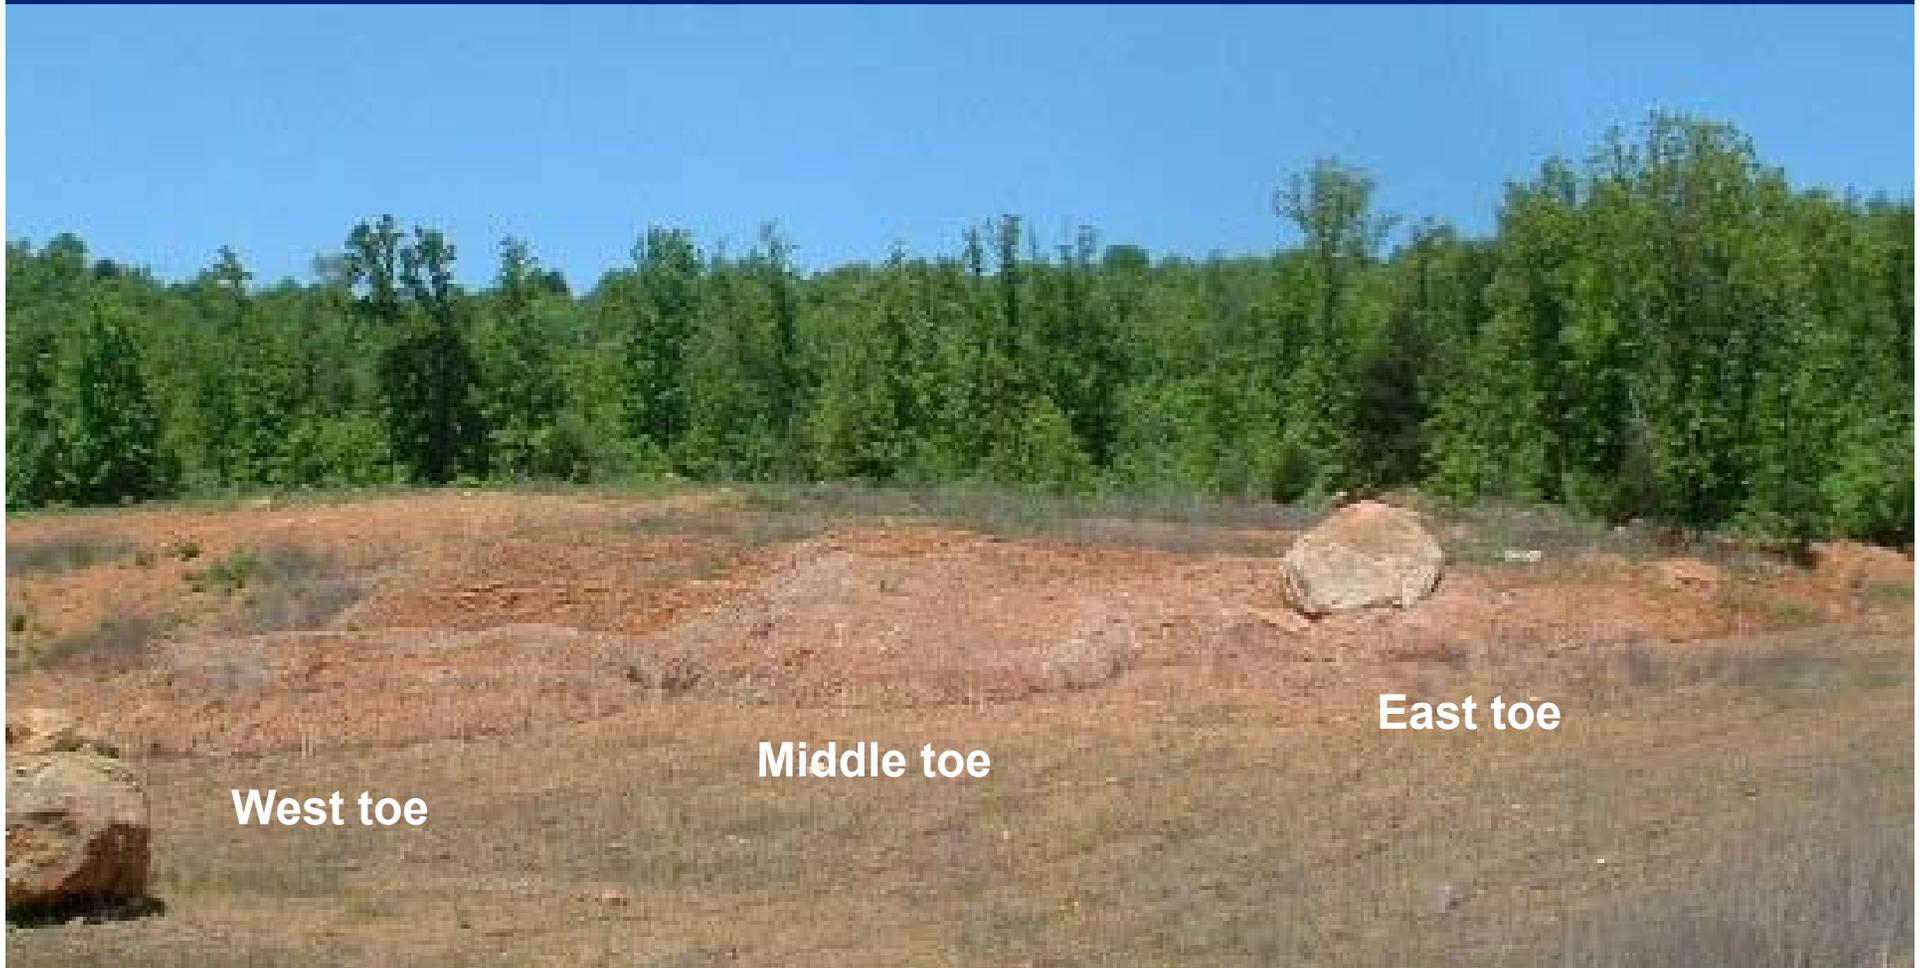
Active west toe

View ~ normal to landslide toe showing 3 distinct toes

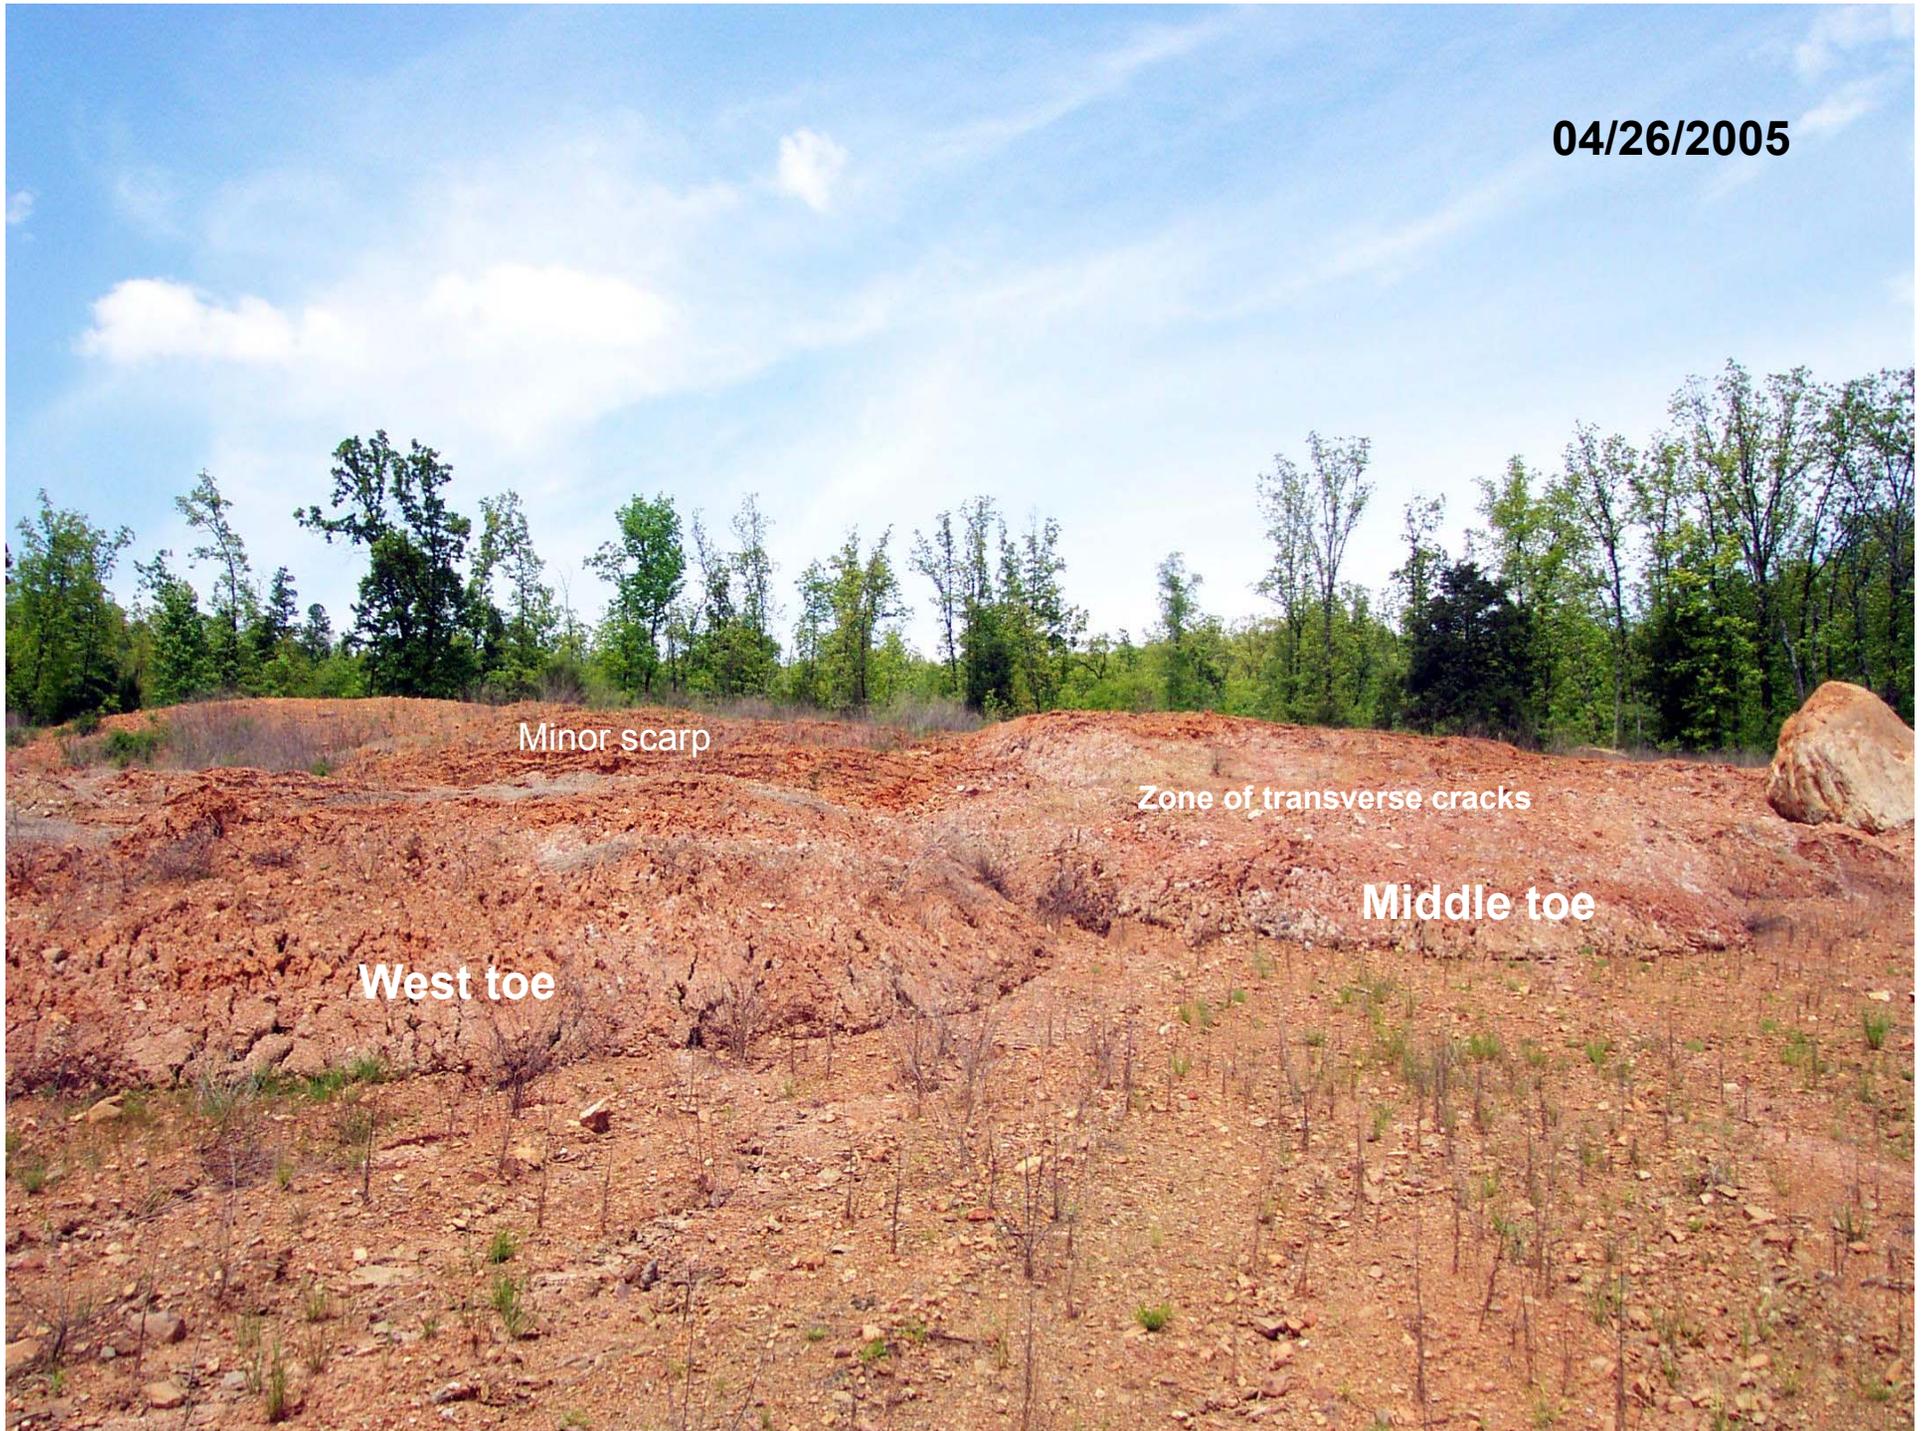
Minor scarp

Zone of transverse cracks

Middle toe

West toe

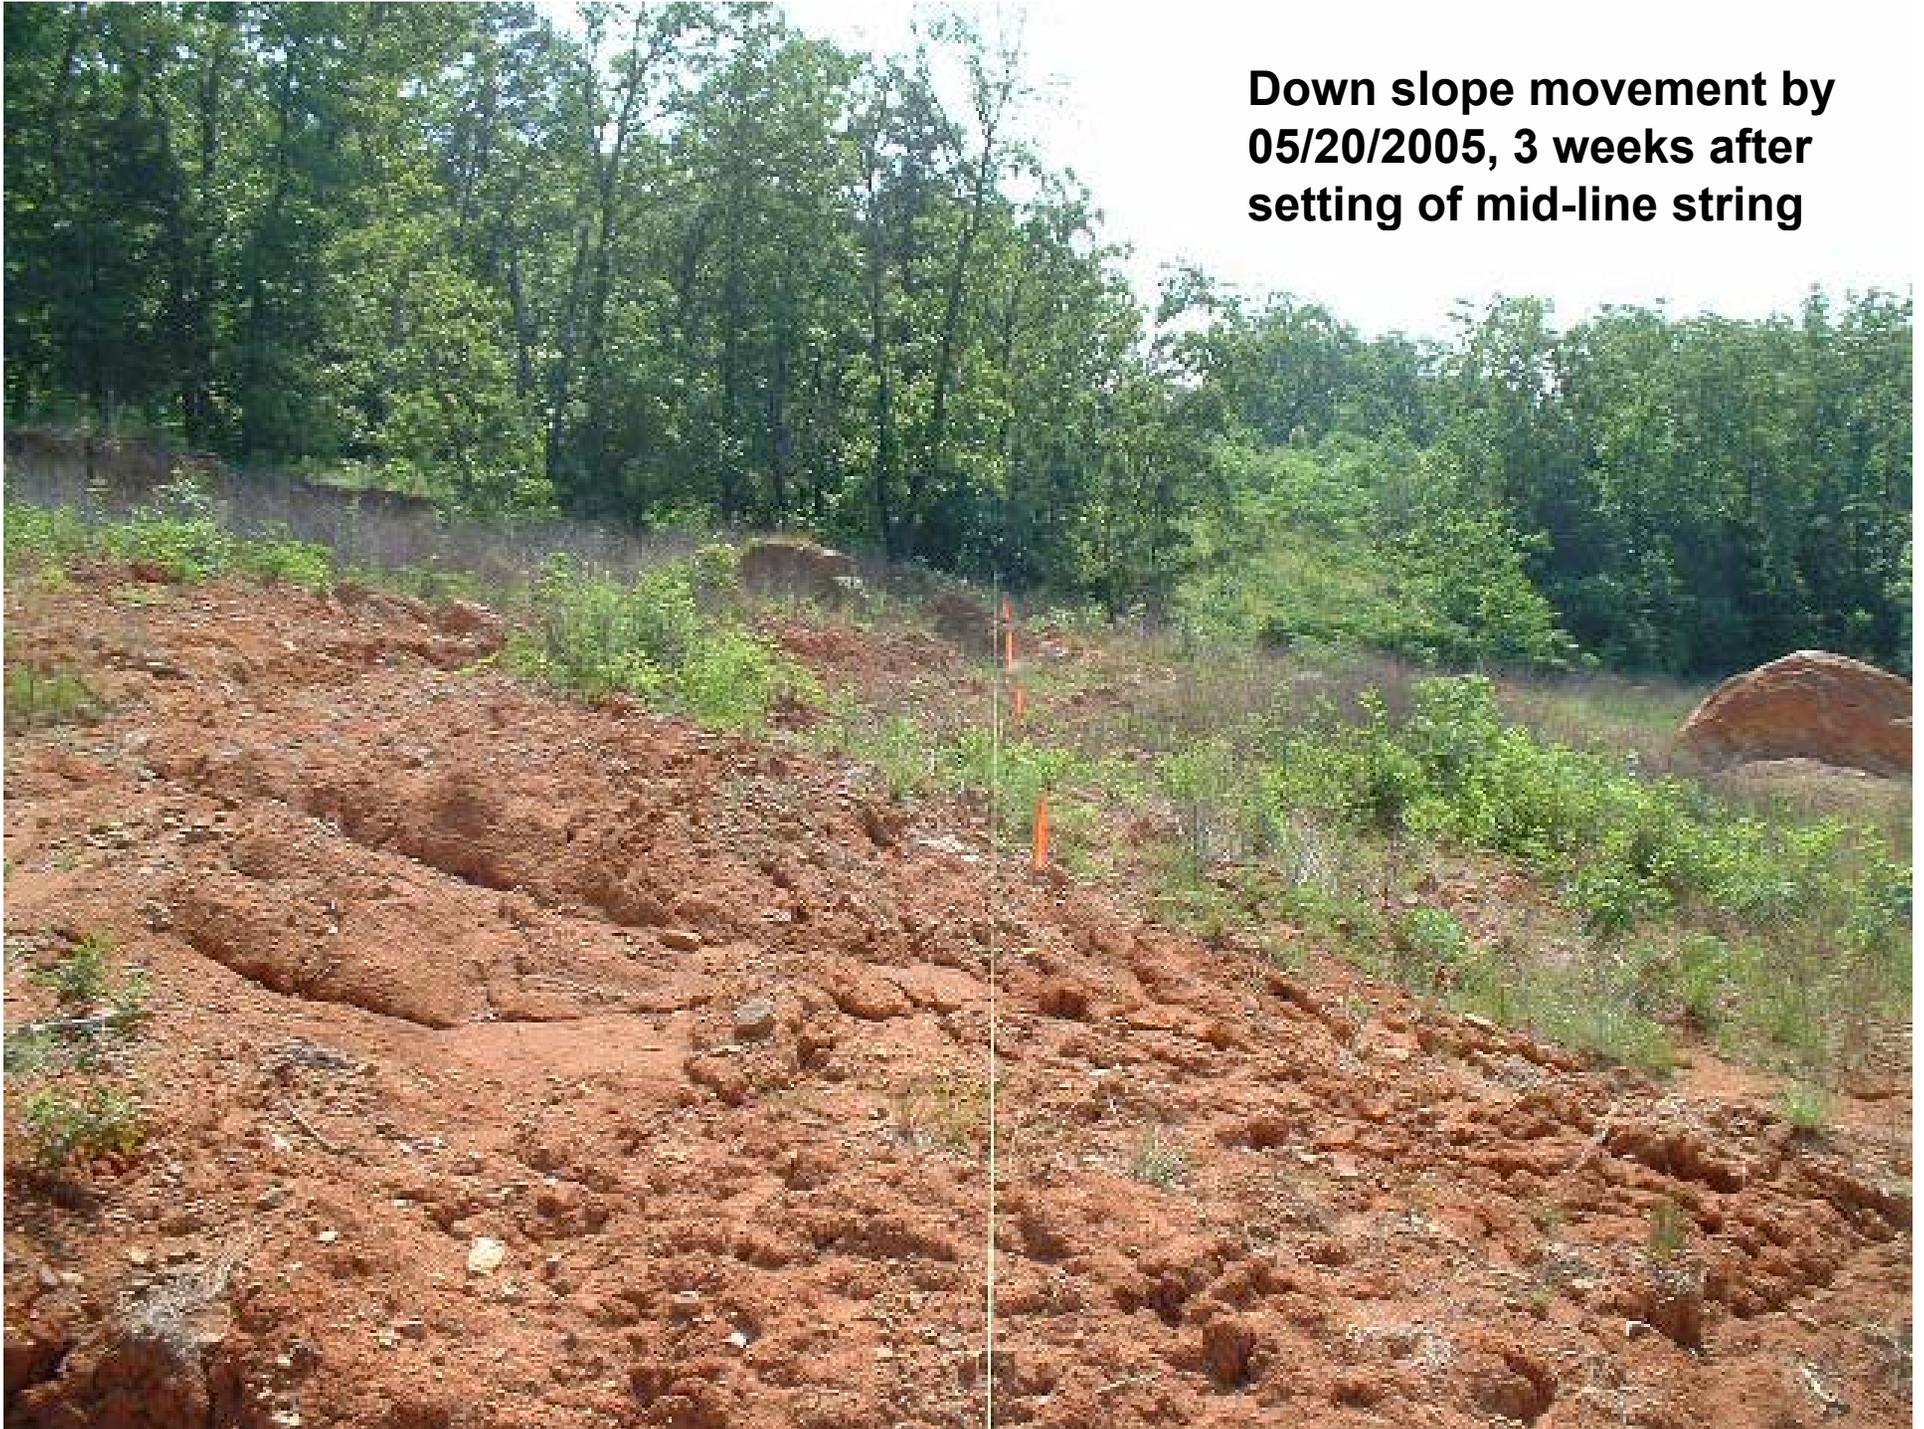
**Down slope movement by
05/20/2005, 3 weeks after
setting of mid-line string**

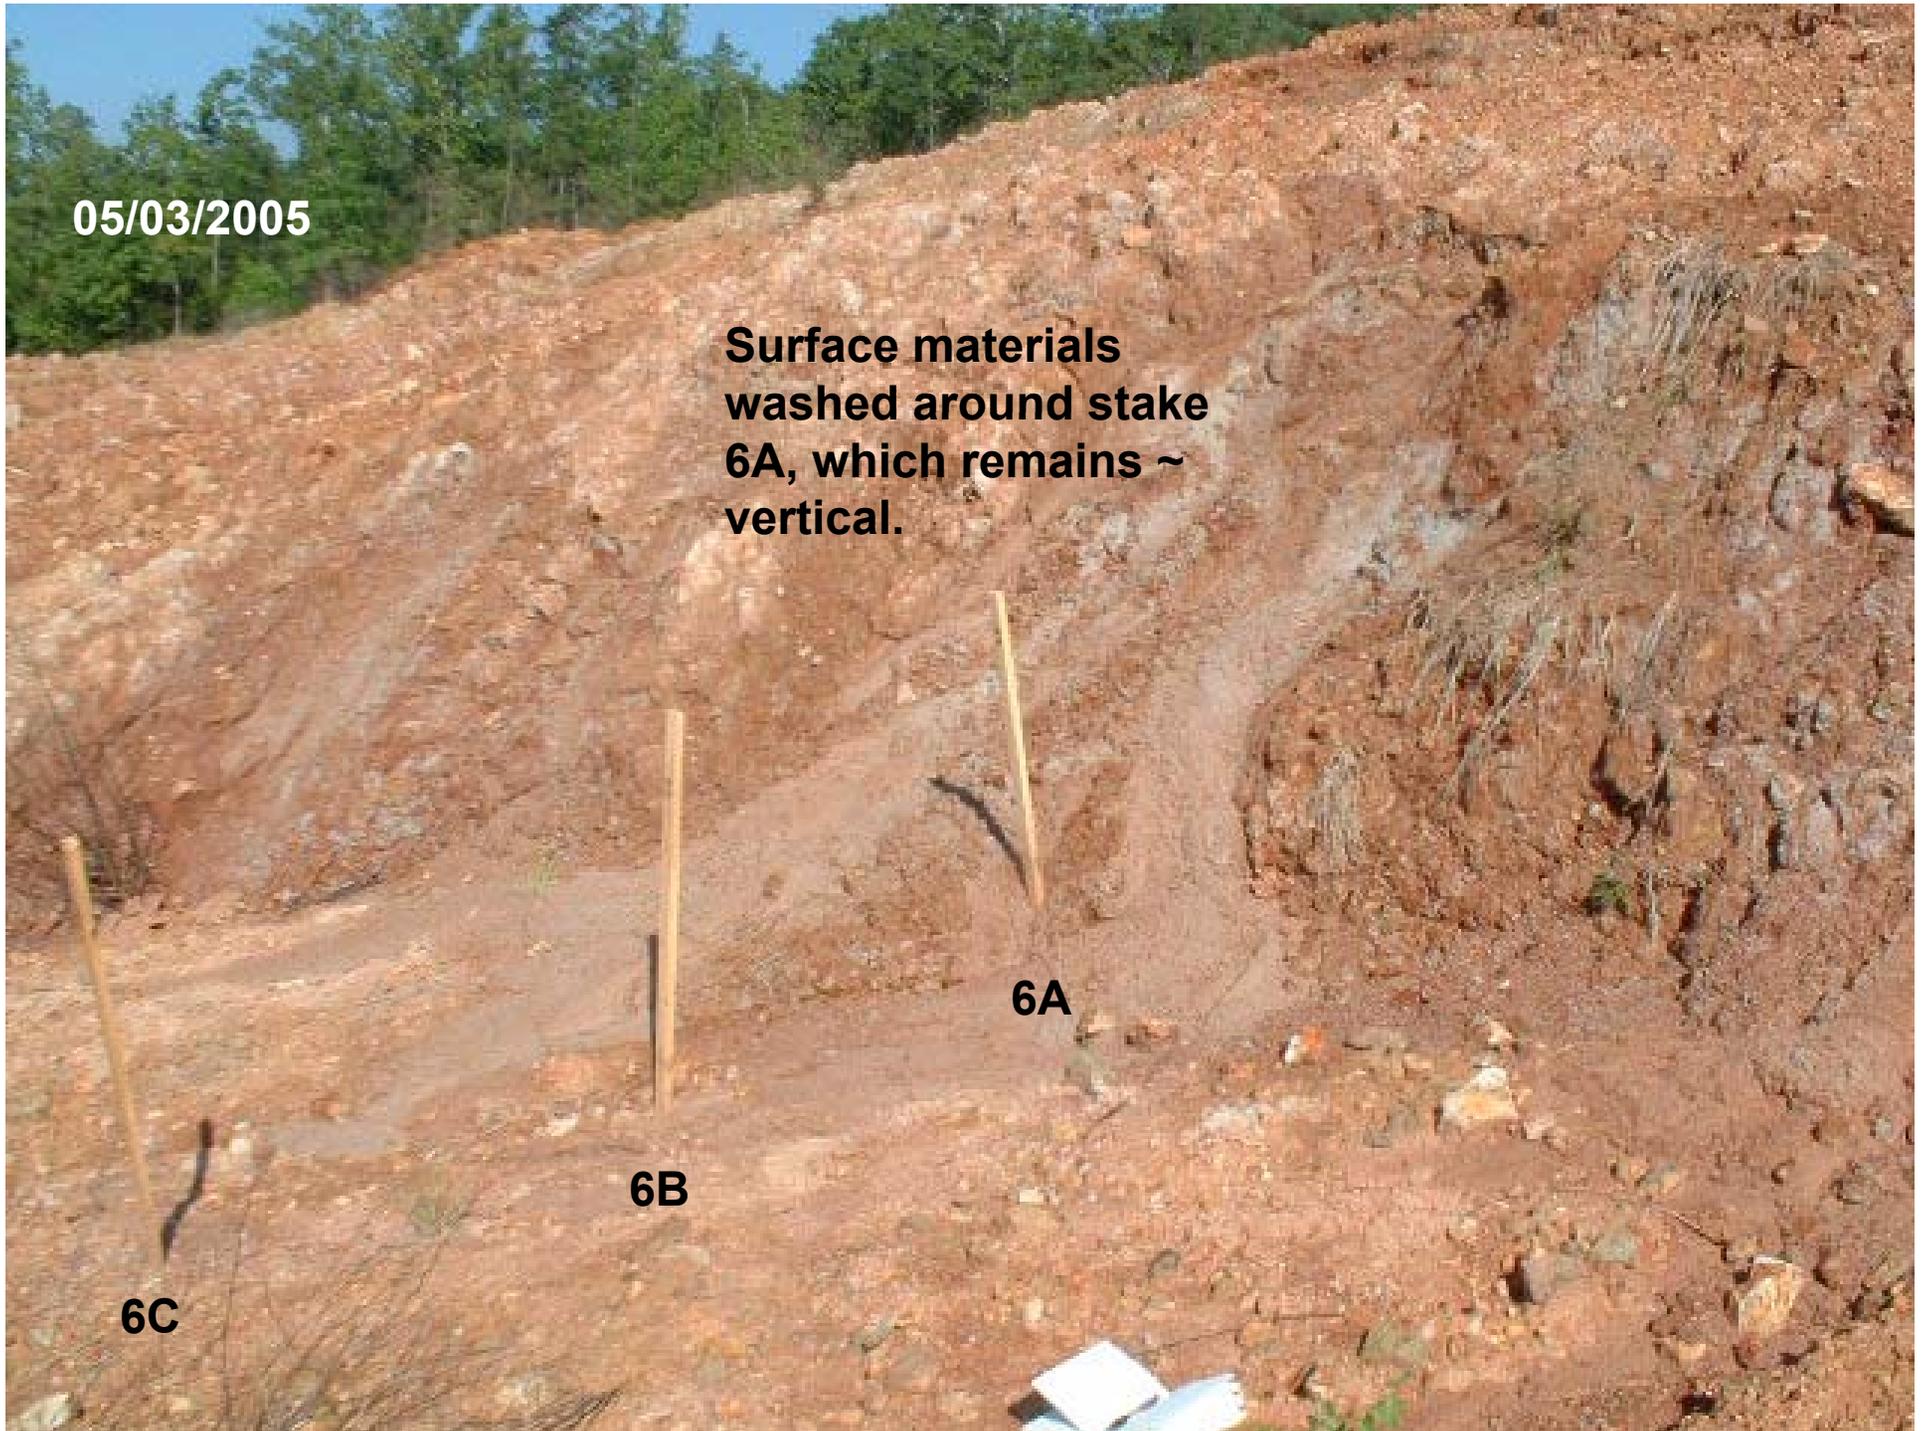
Surface materials
washed around stake
6A, which remains ~
vertical.

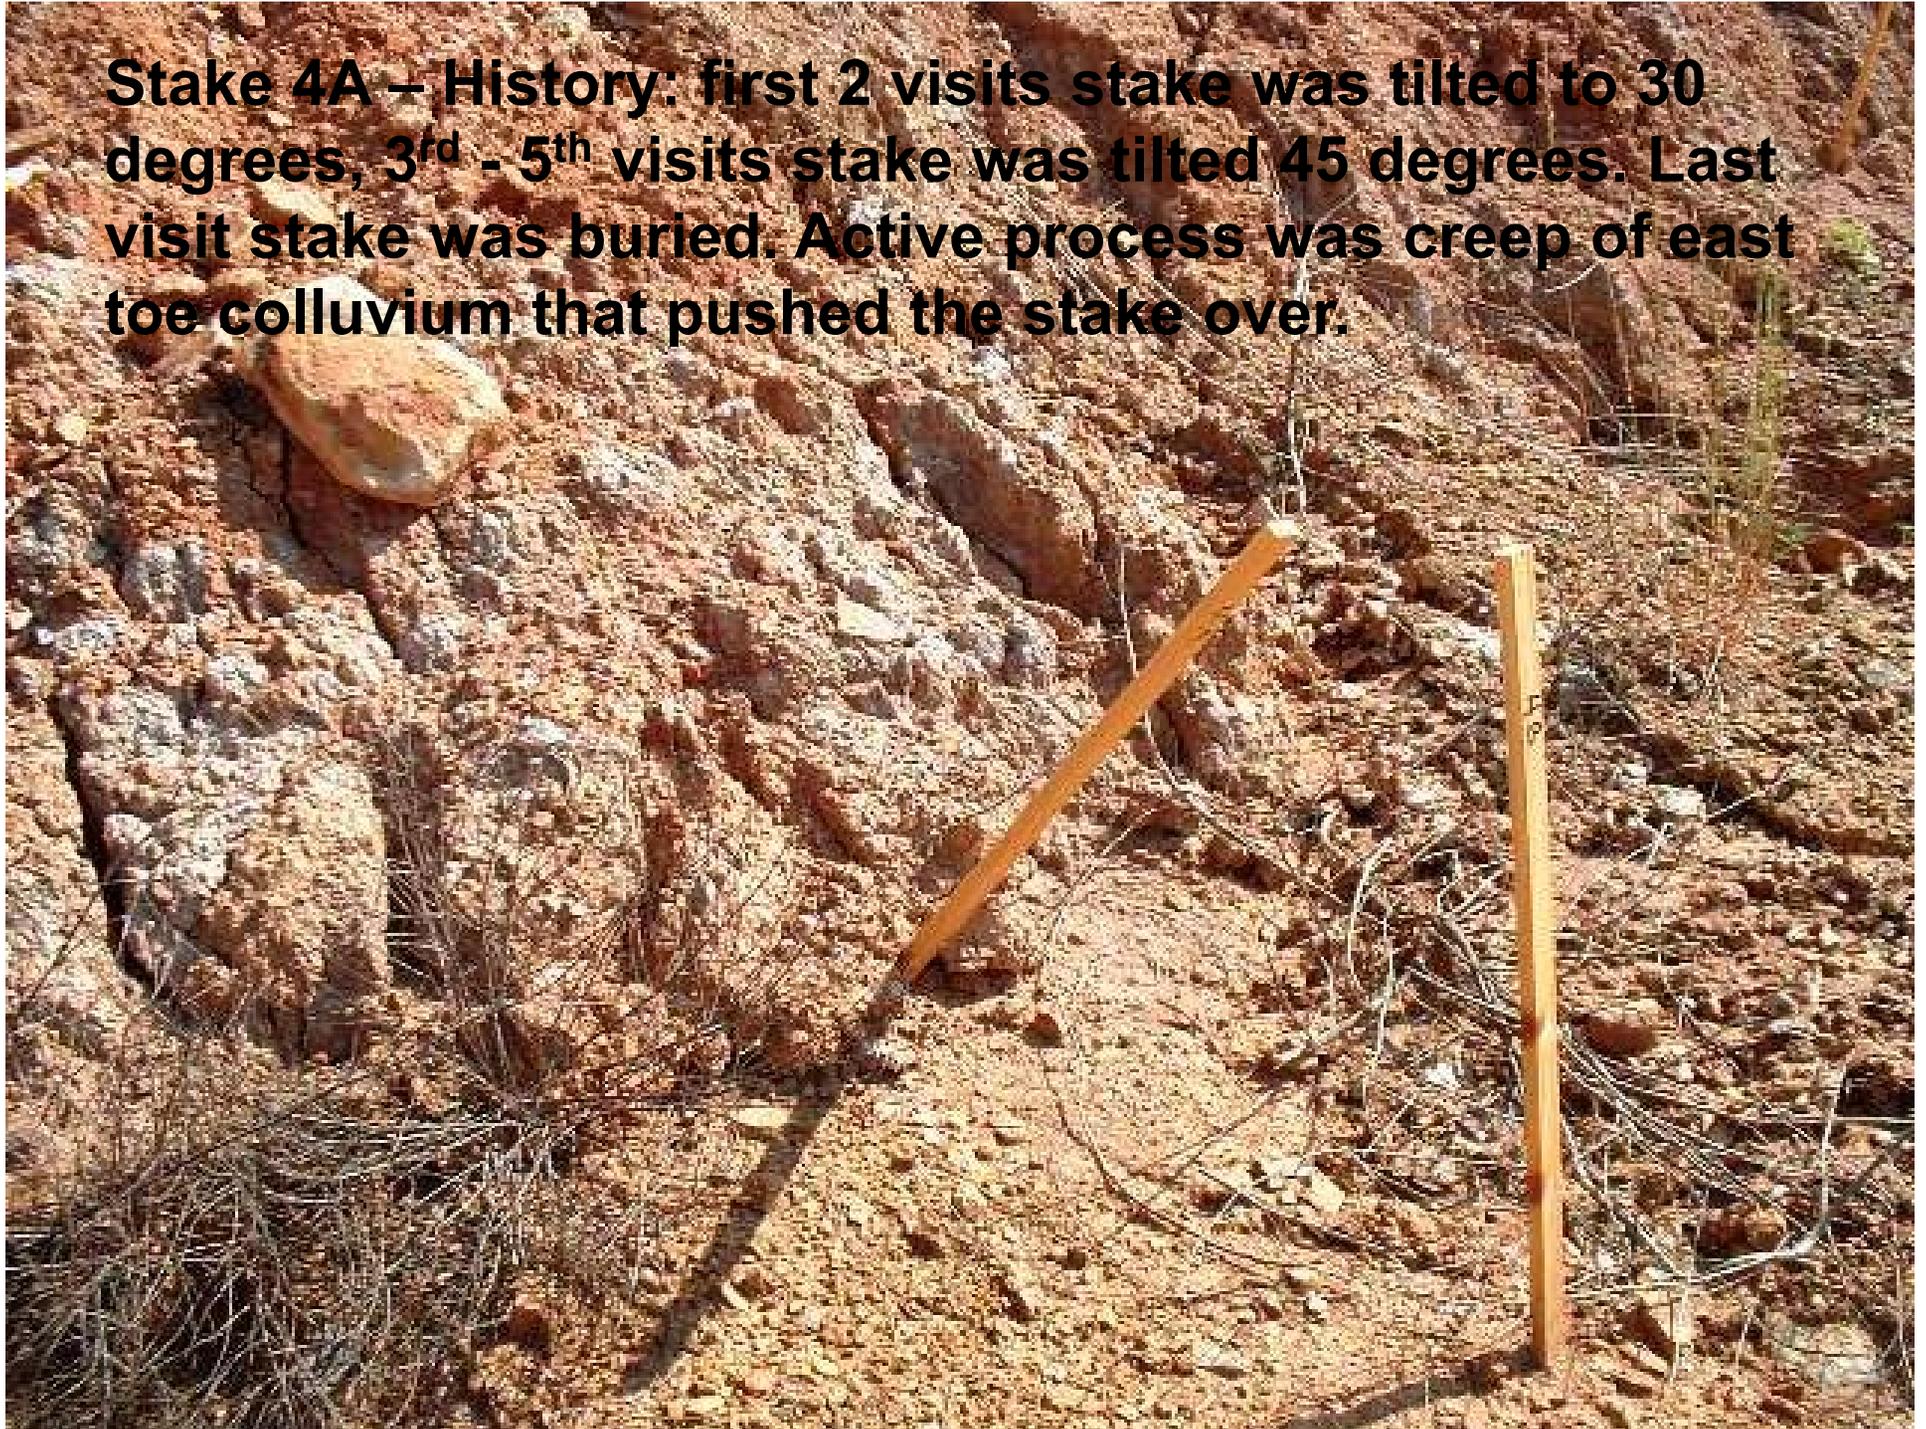
Stake 4A – History: first 2 visits stake was tilted to 30 degrees, 3rd - 5th visits stake was tilted 45 degrees. Last visit stake was buried. Active process was creep of east toe colluvium that pushed the stake over.
