Jones Landslide, Pottsville, Arkansas – 2 ½ years of Monitoring

By
J. Michael Howard

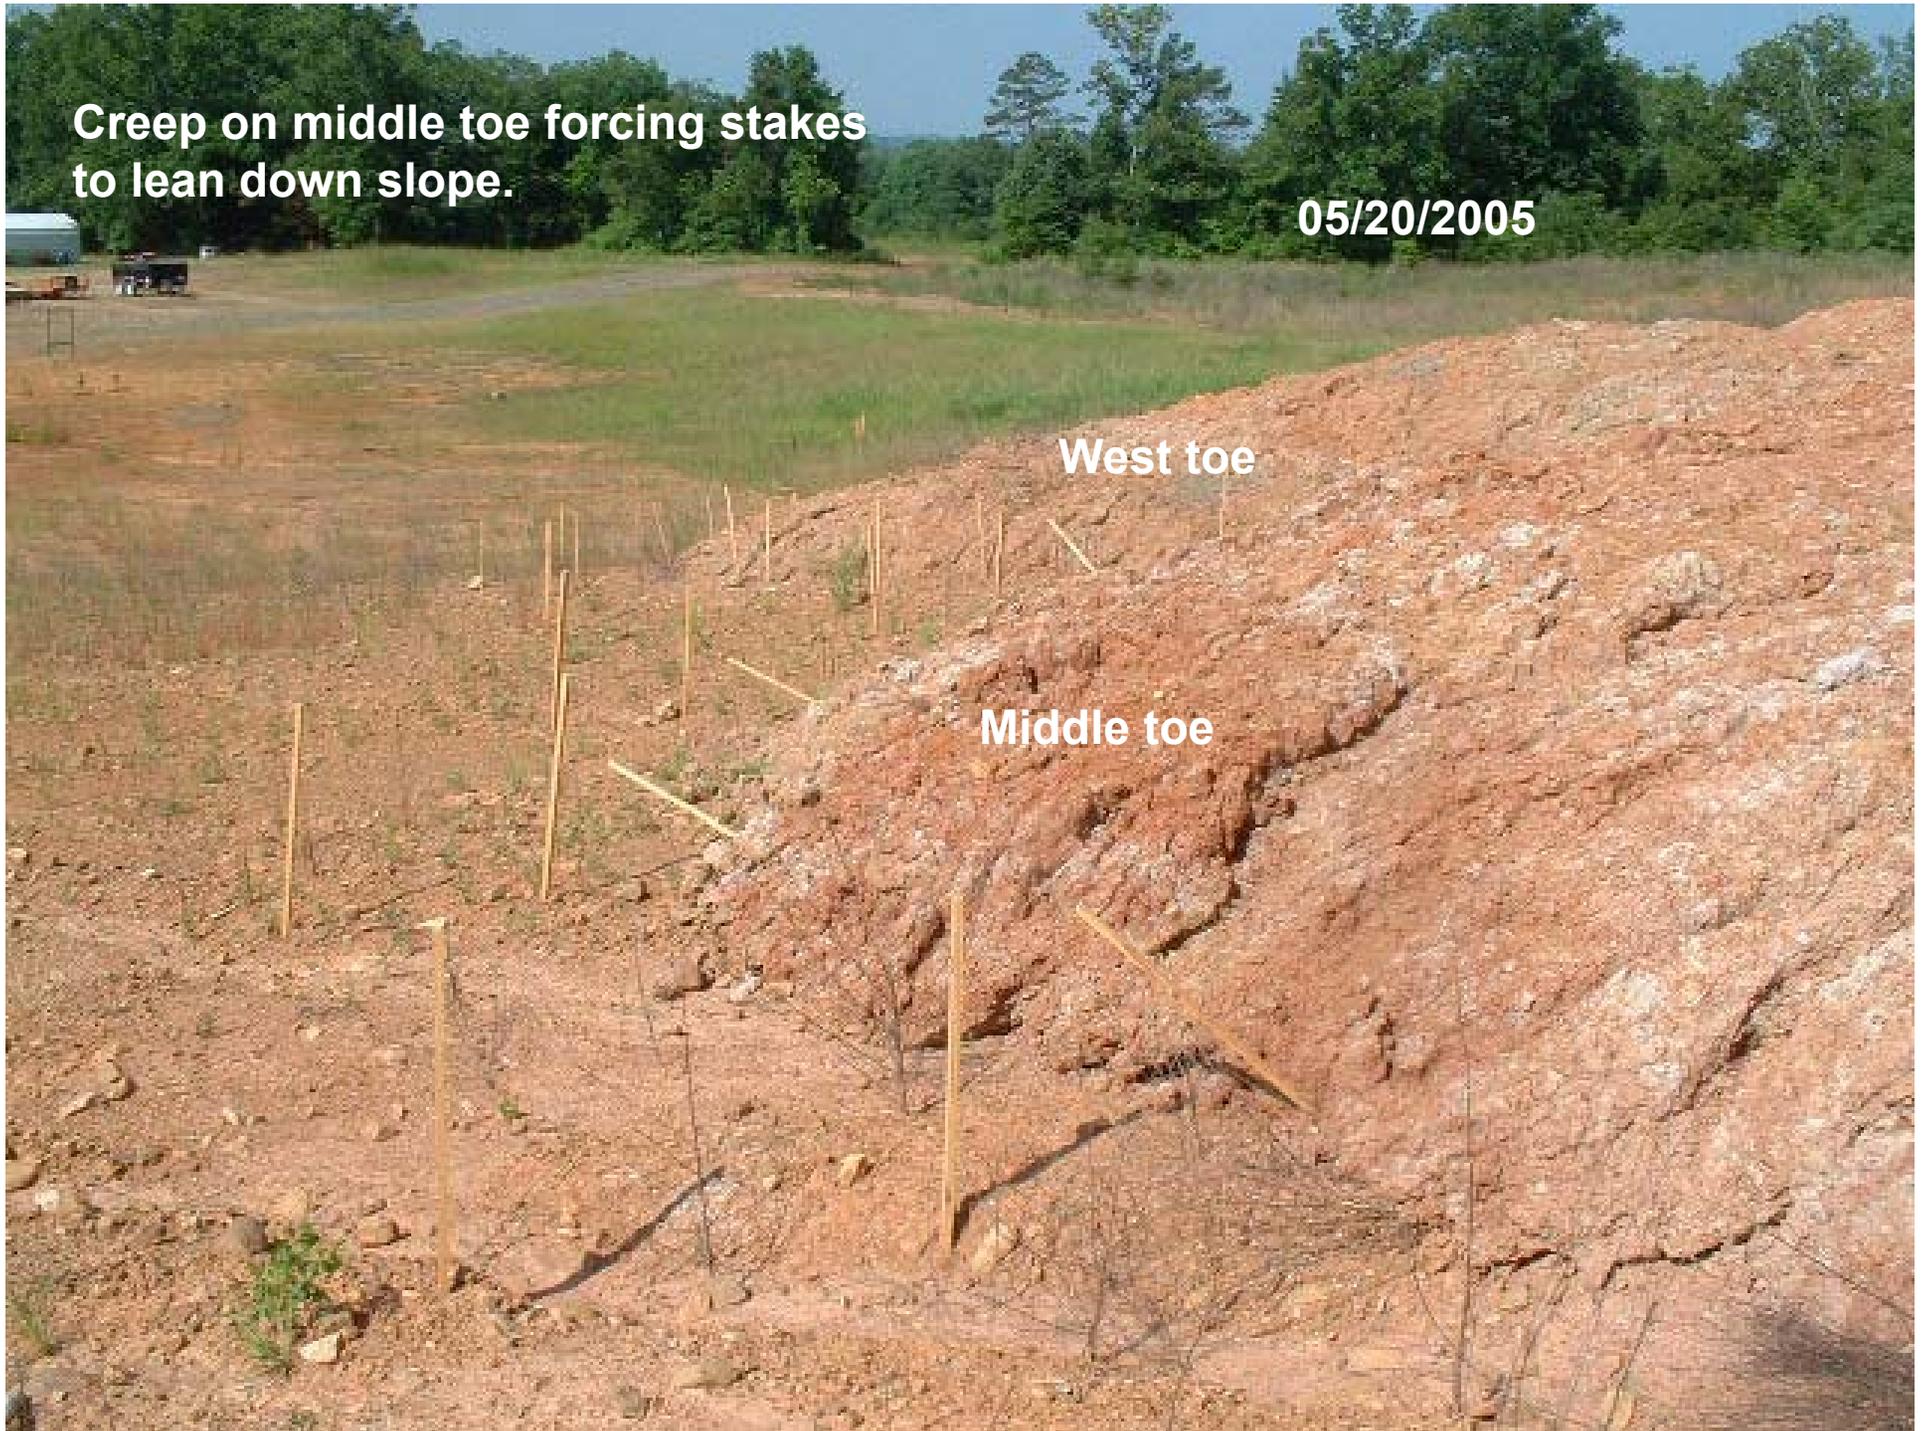
Stake 10B History: stake was vertical all previous visits until noted horizontal on 07/10/06. Note that 11B is also horizontal. 10A & 11A are buried by process of creep of middle toe.

Creep on middle toe forcing stakes
to lean down slope.

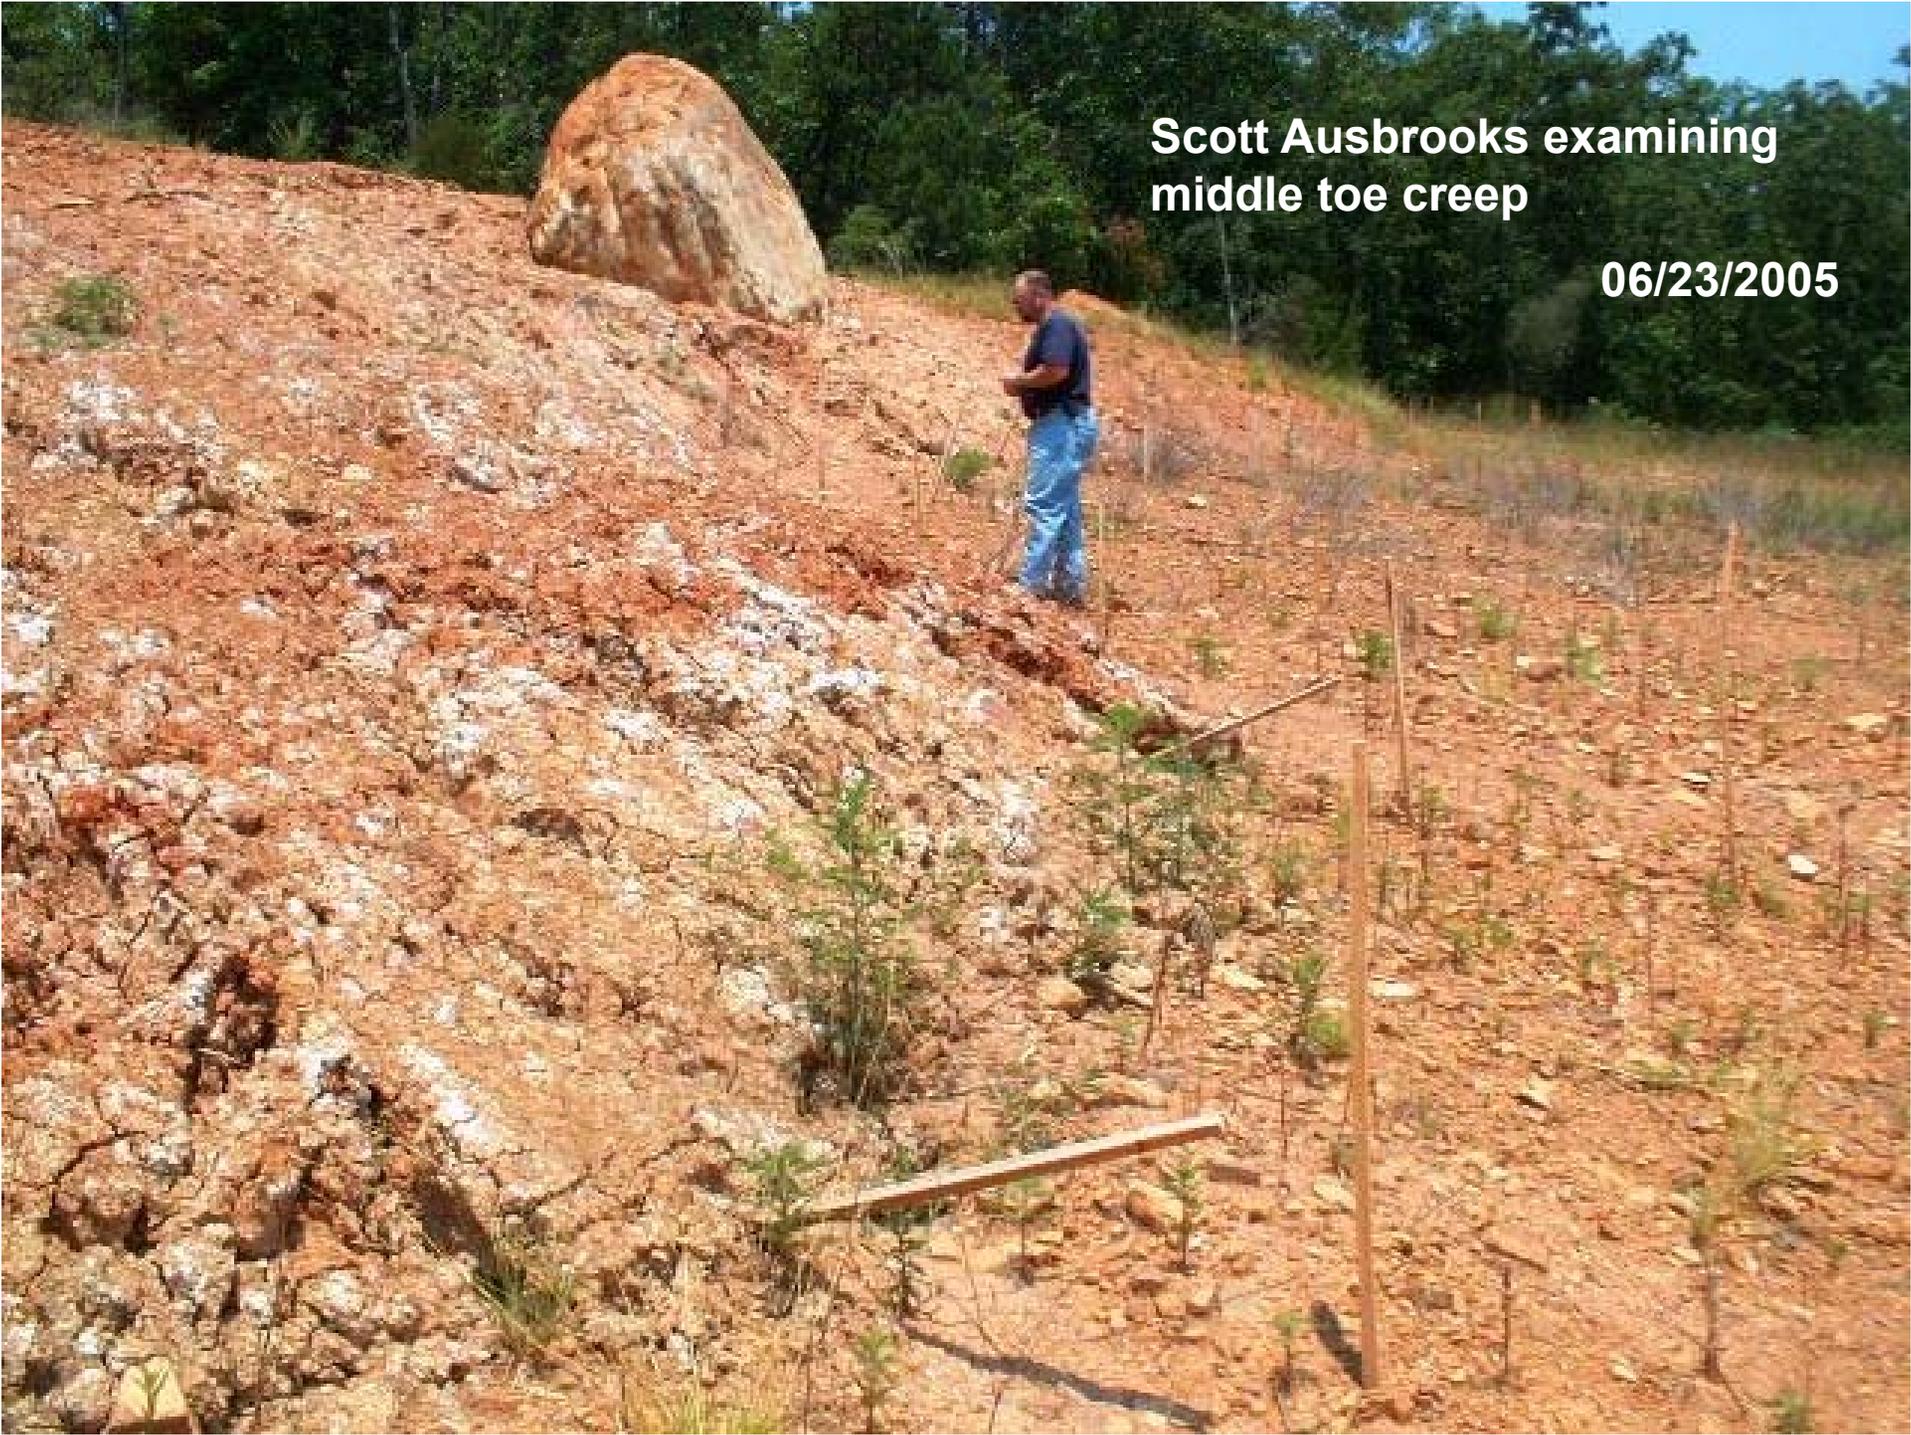
**Scott Ausbrooks examining
middle toe creep**

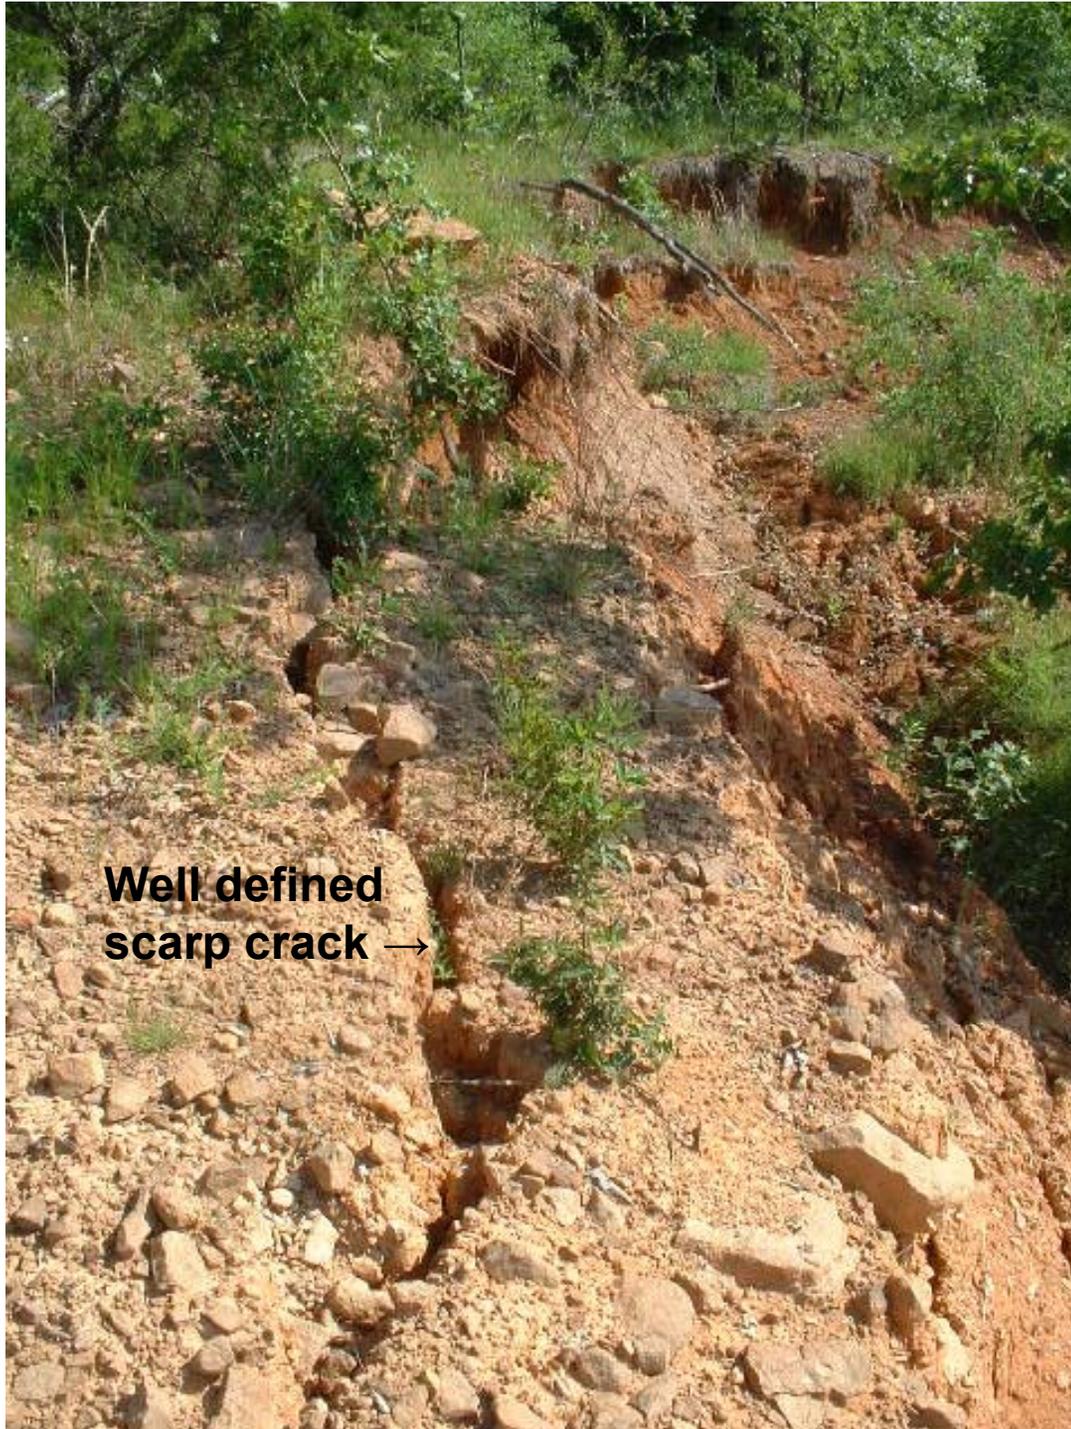
**Well defined
scarp crack →**

**Continued erosion by
developing drainage on
west edge of landslide
resulted in development of
scarp crack by mass
wasting of unconsolidated
colluvium into drainage,
looking northeast.**

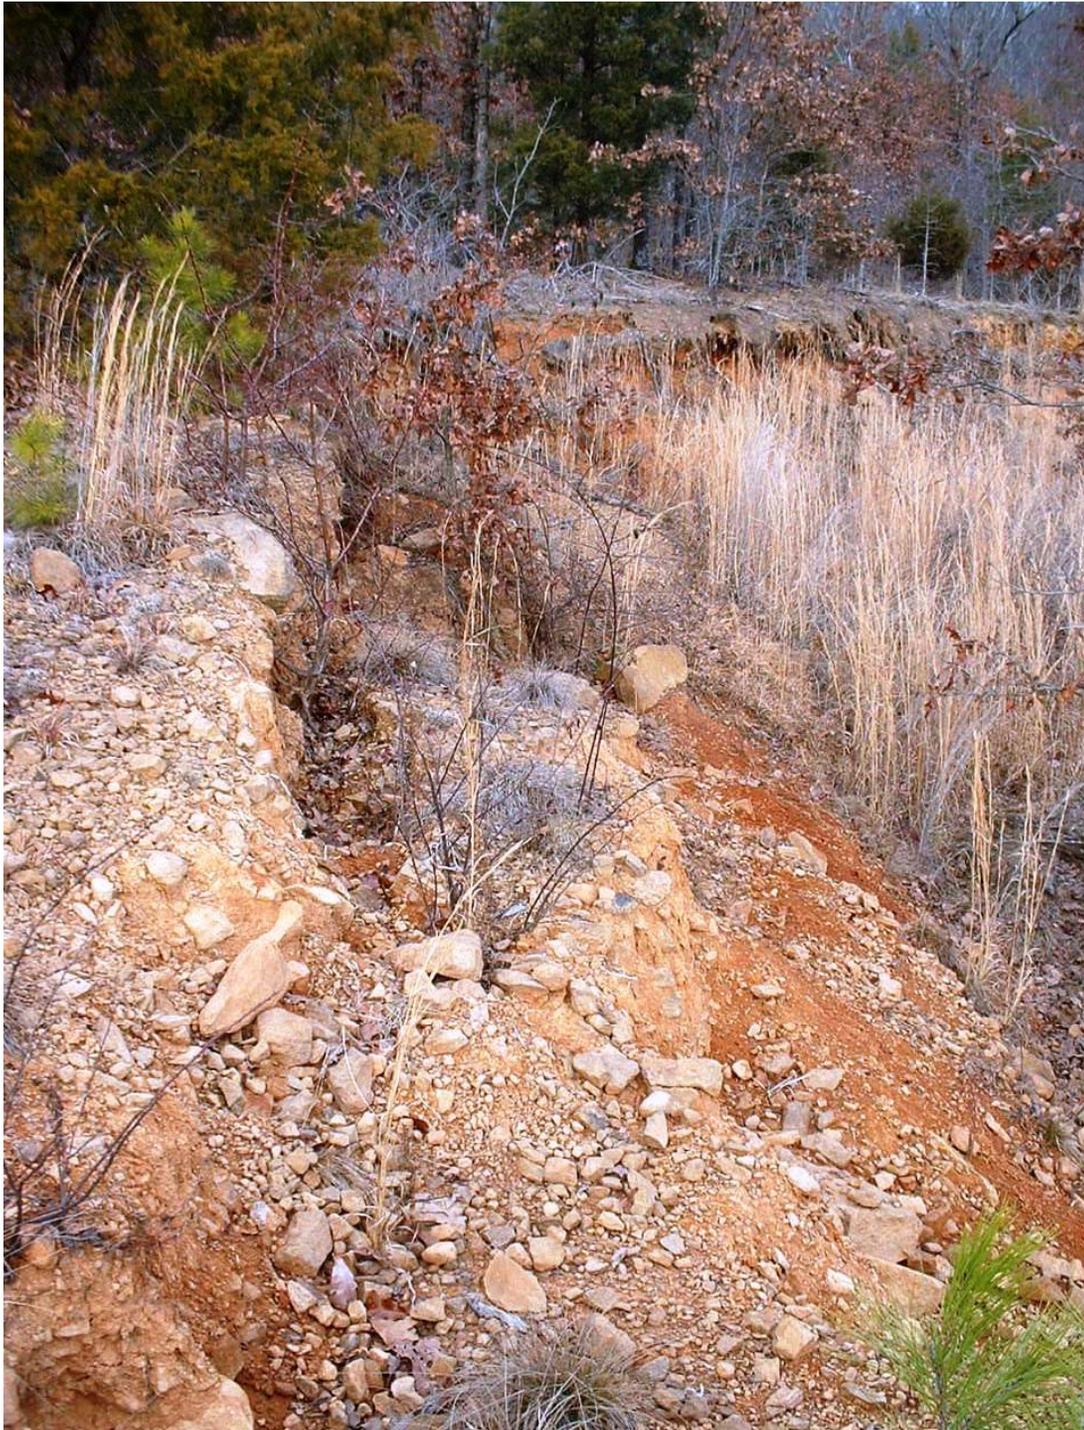
**Note down drop of slump
block into the slide and
covering of crack extension
by wash. Look direction is
north.**

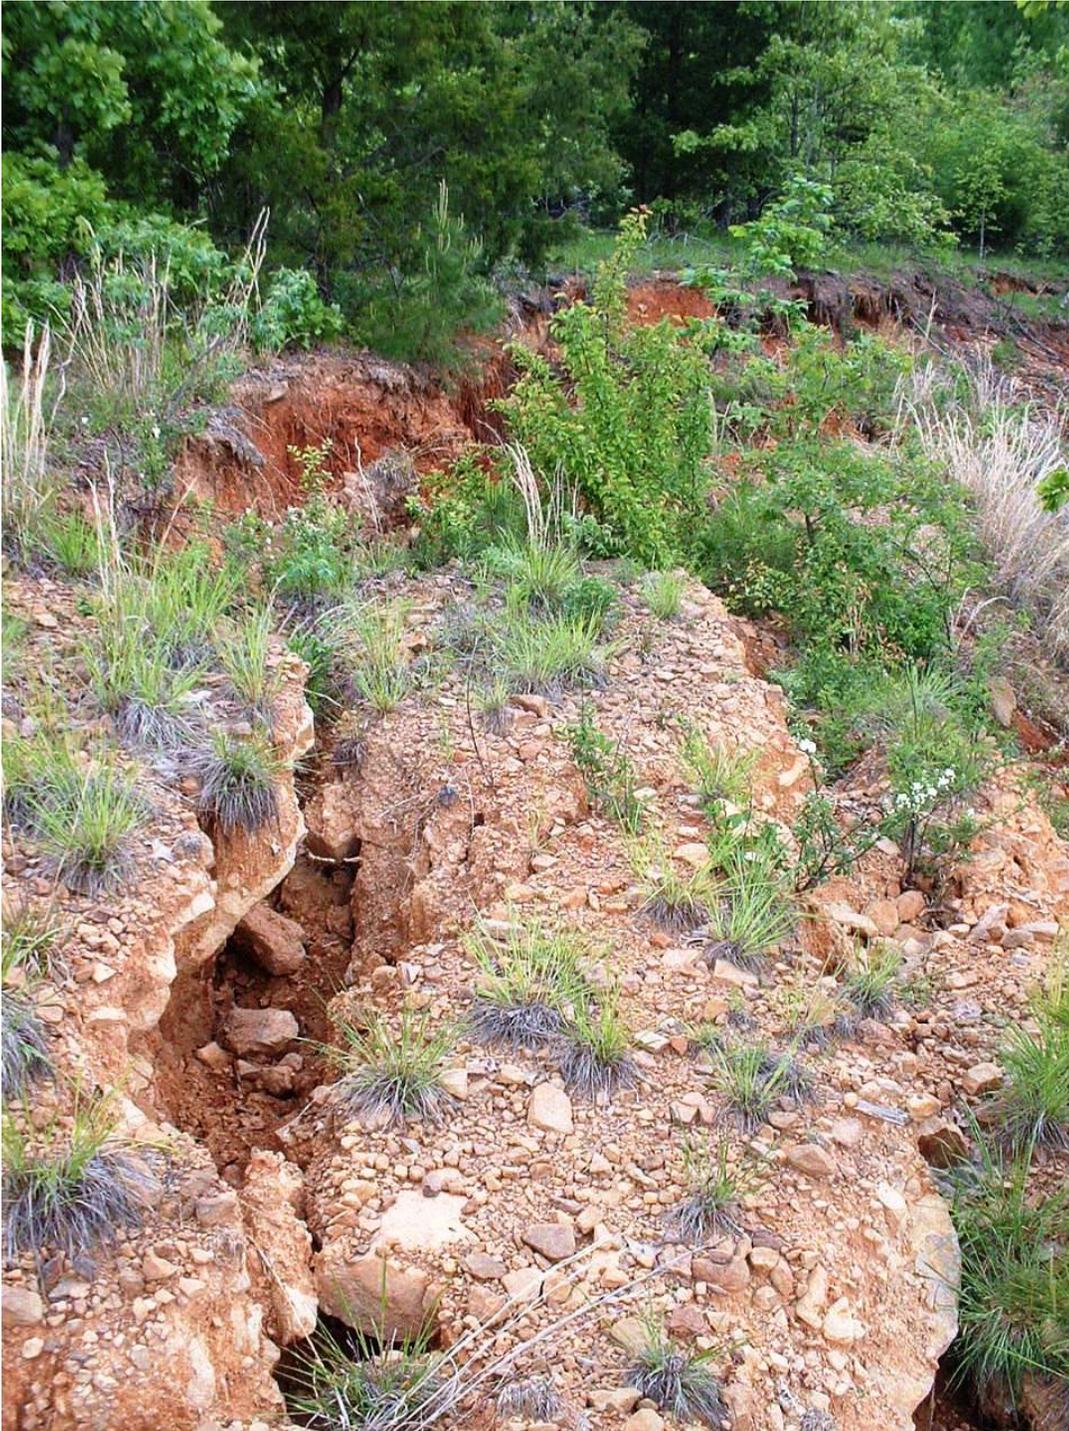
**Continued down drop and
separation of block on west
side to the east**

West scarp again exposed

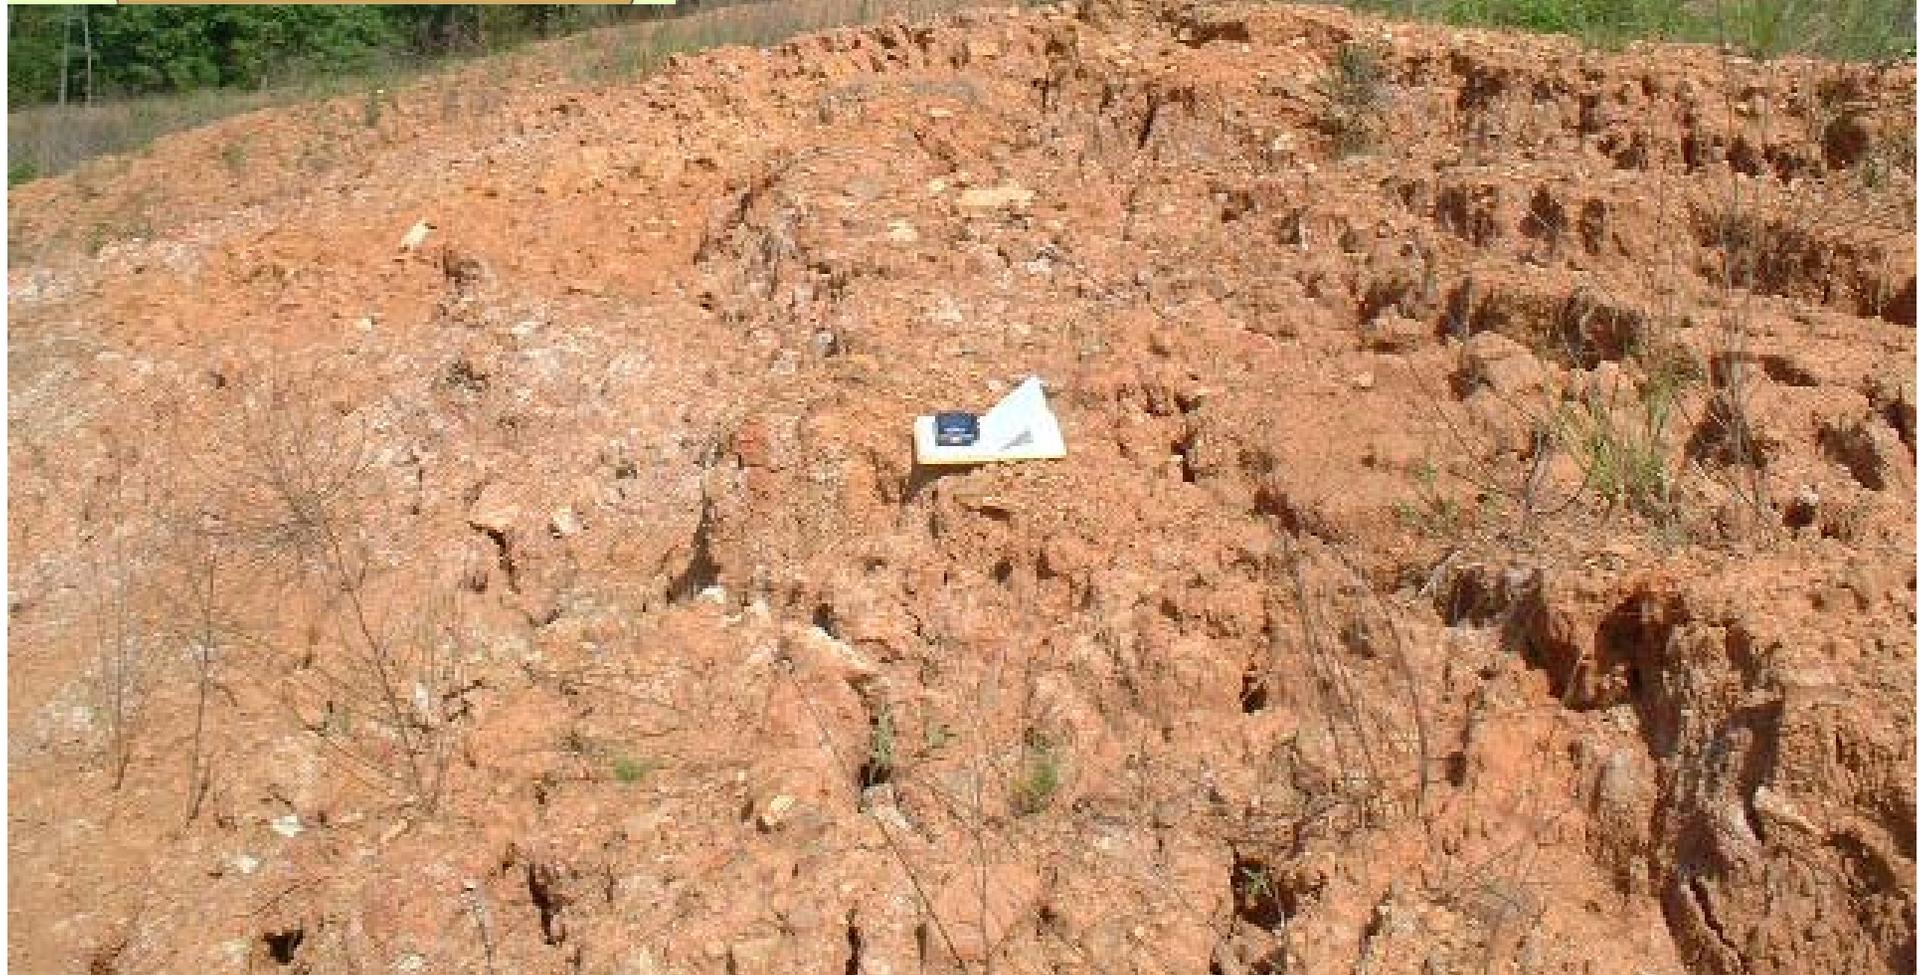
Minor step down scarp development above mid-point of landslide on active middle toe. 05/20/05

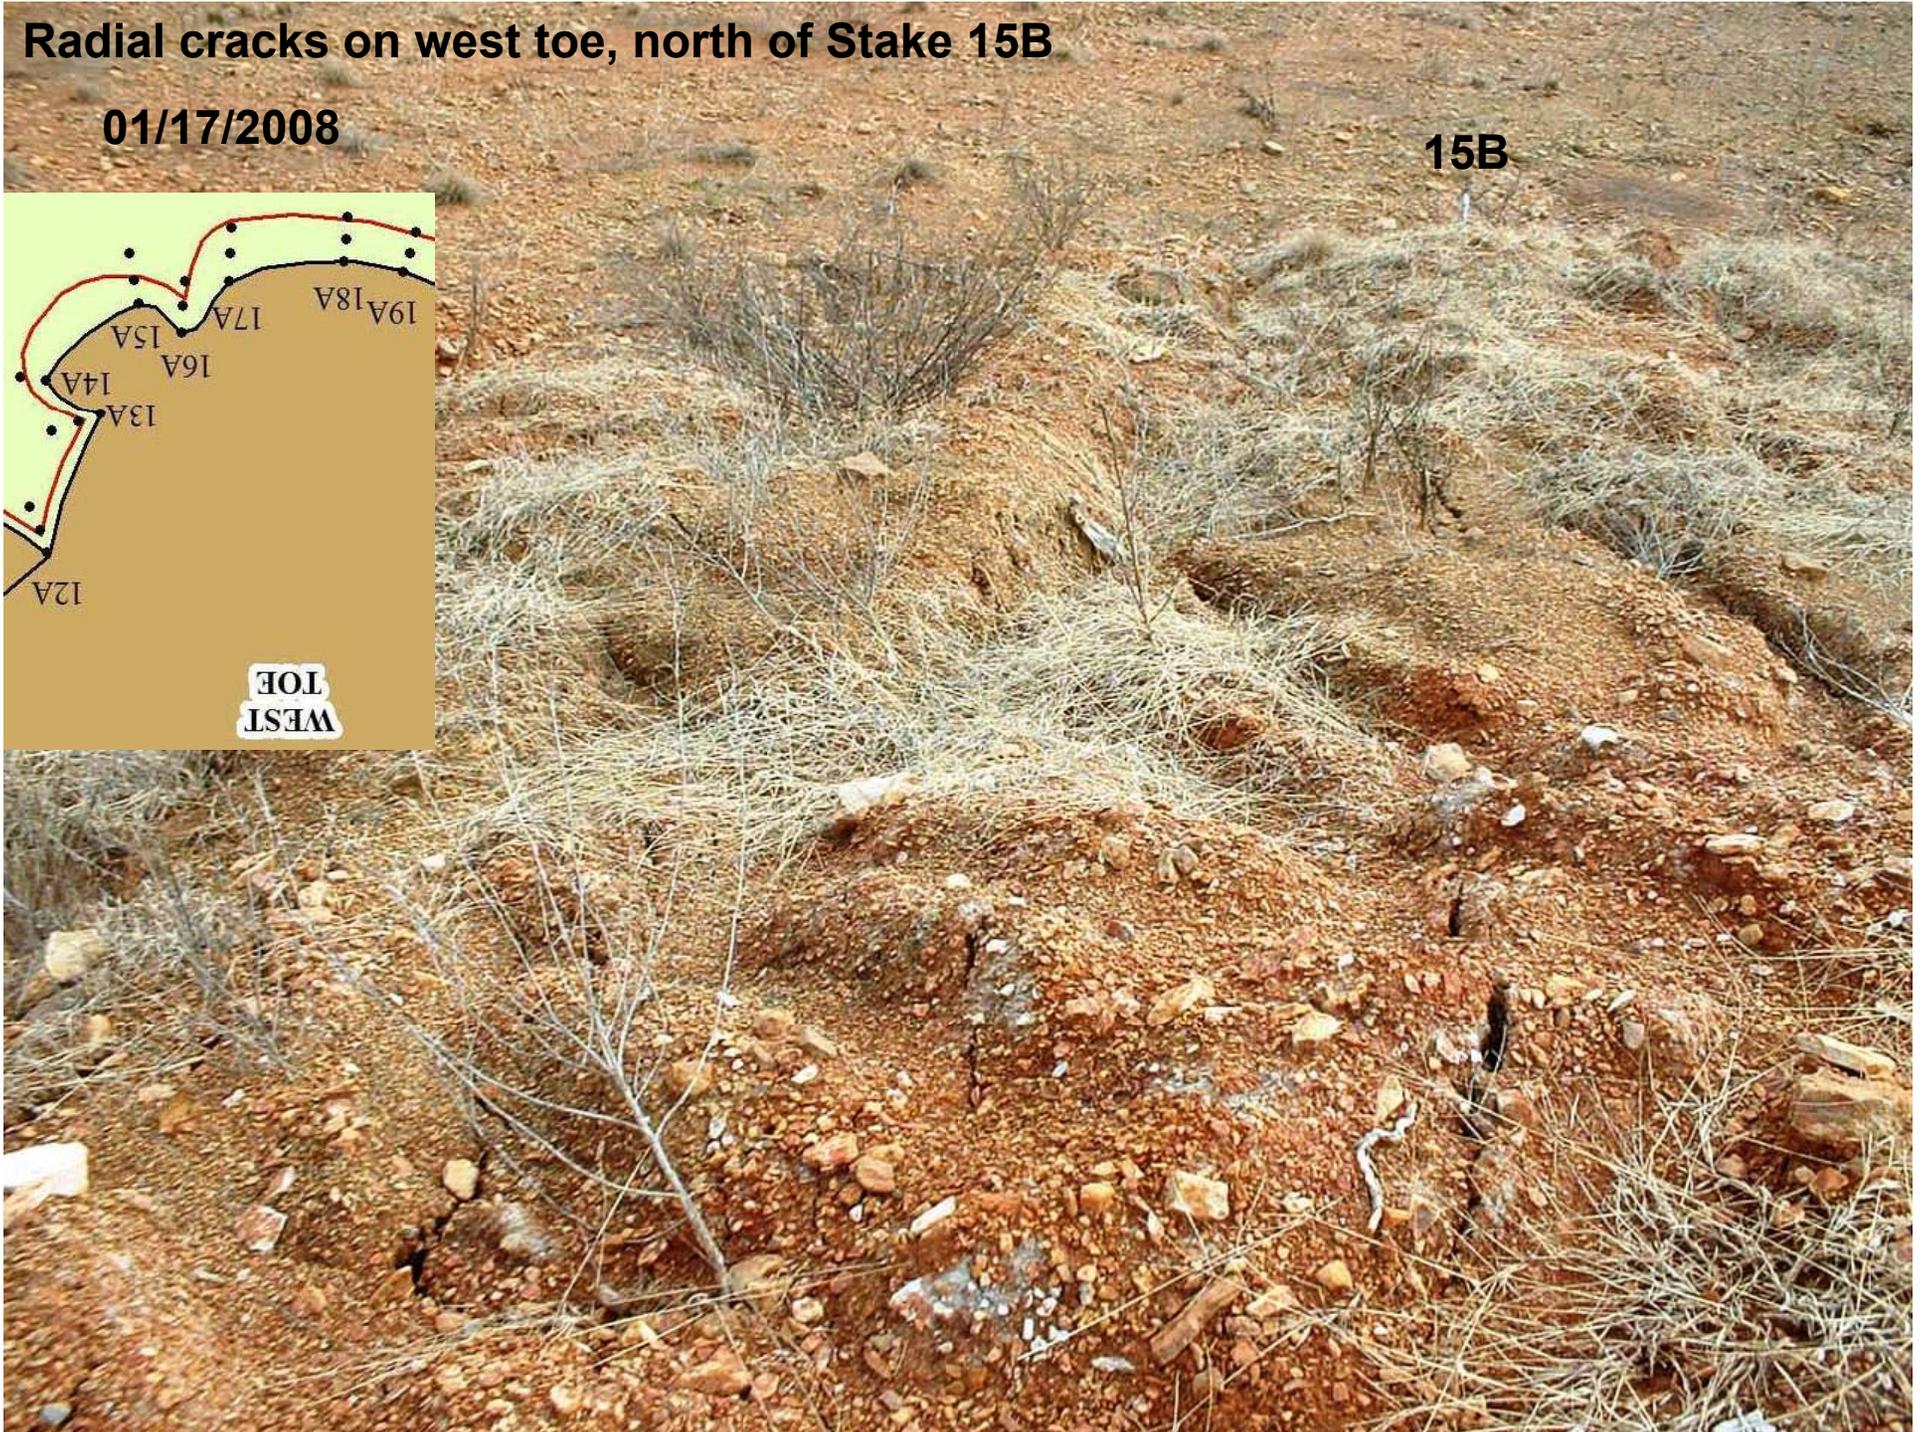
Radial cracks on west toe, north of Stake 15B

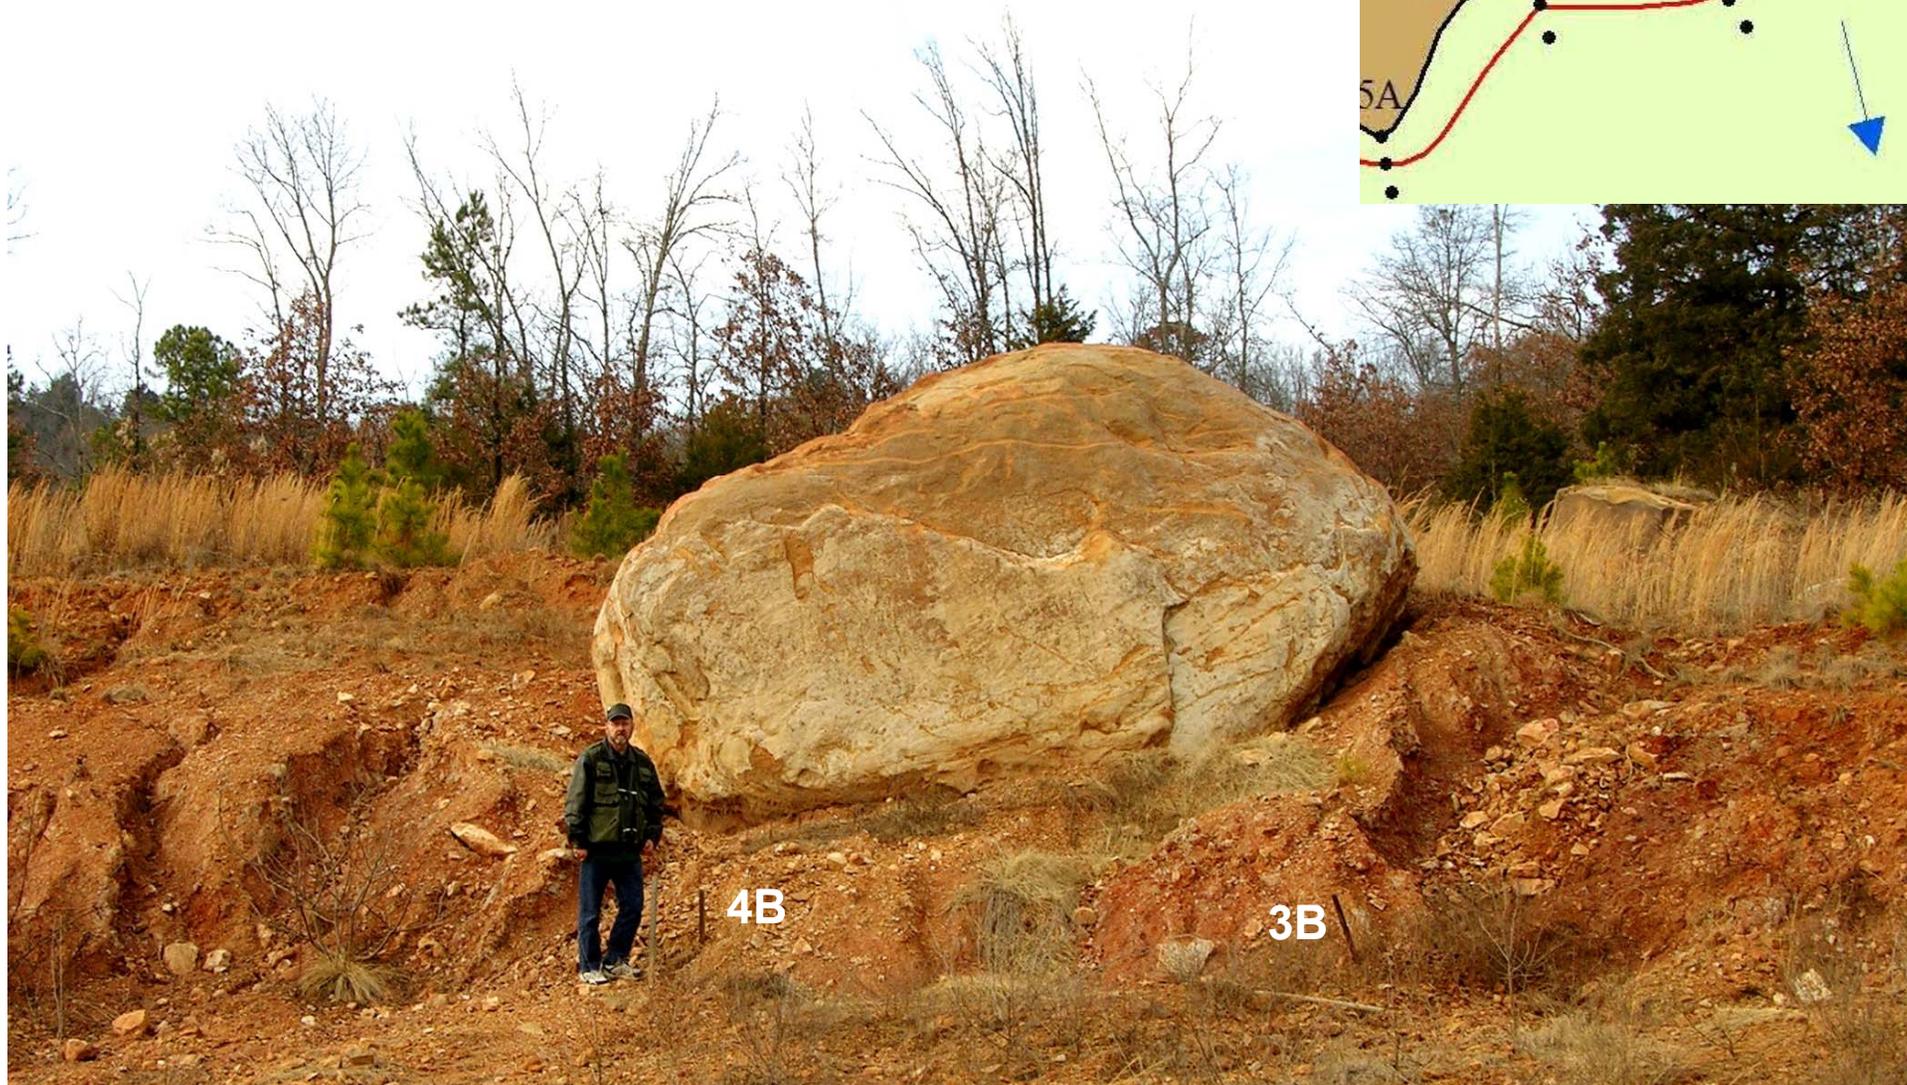
Active gully development on east toe

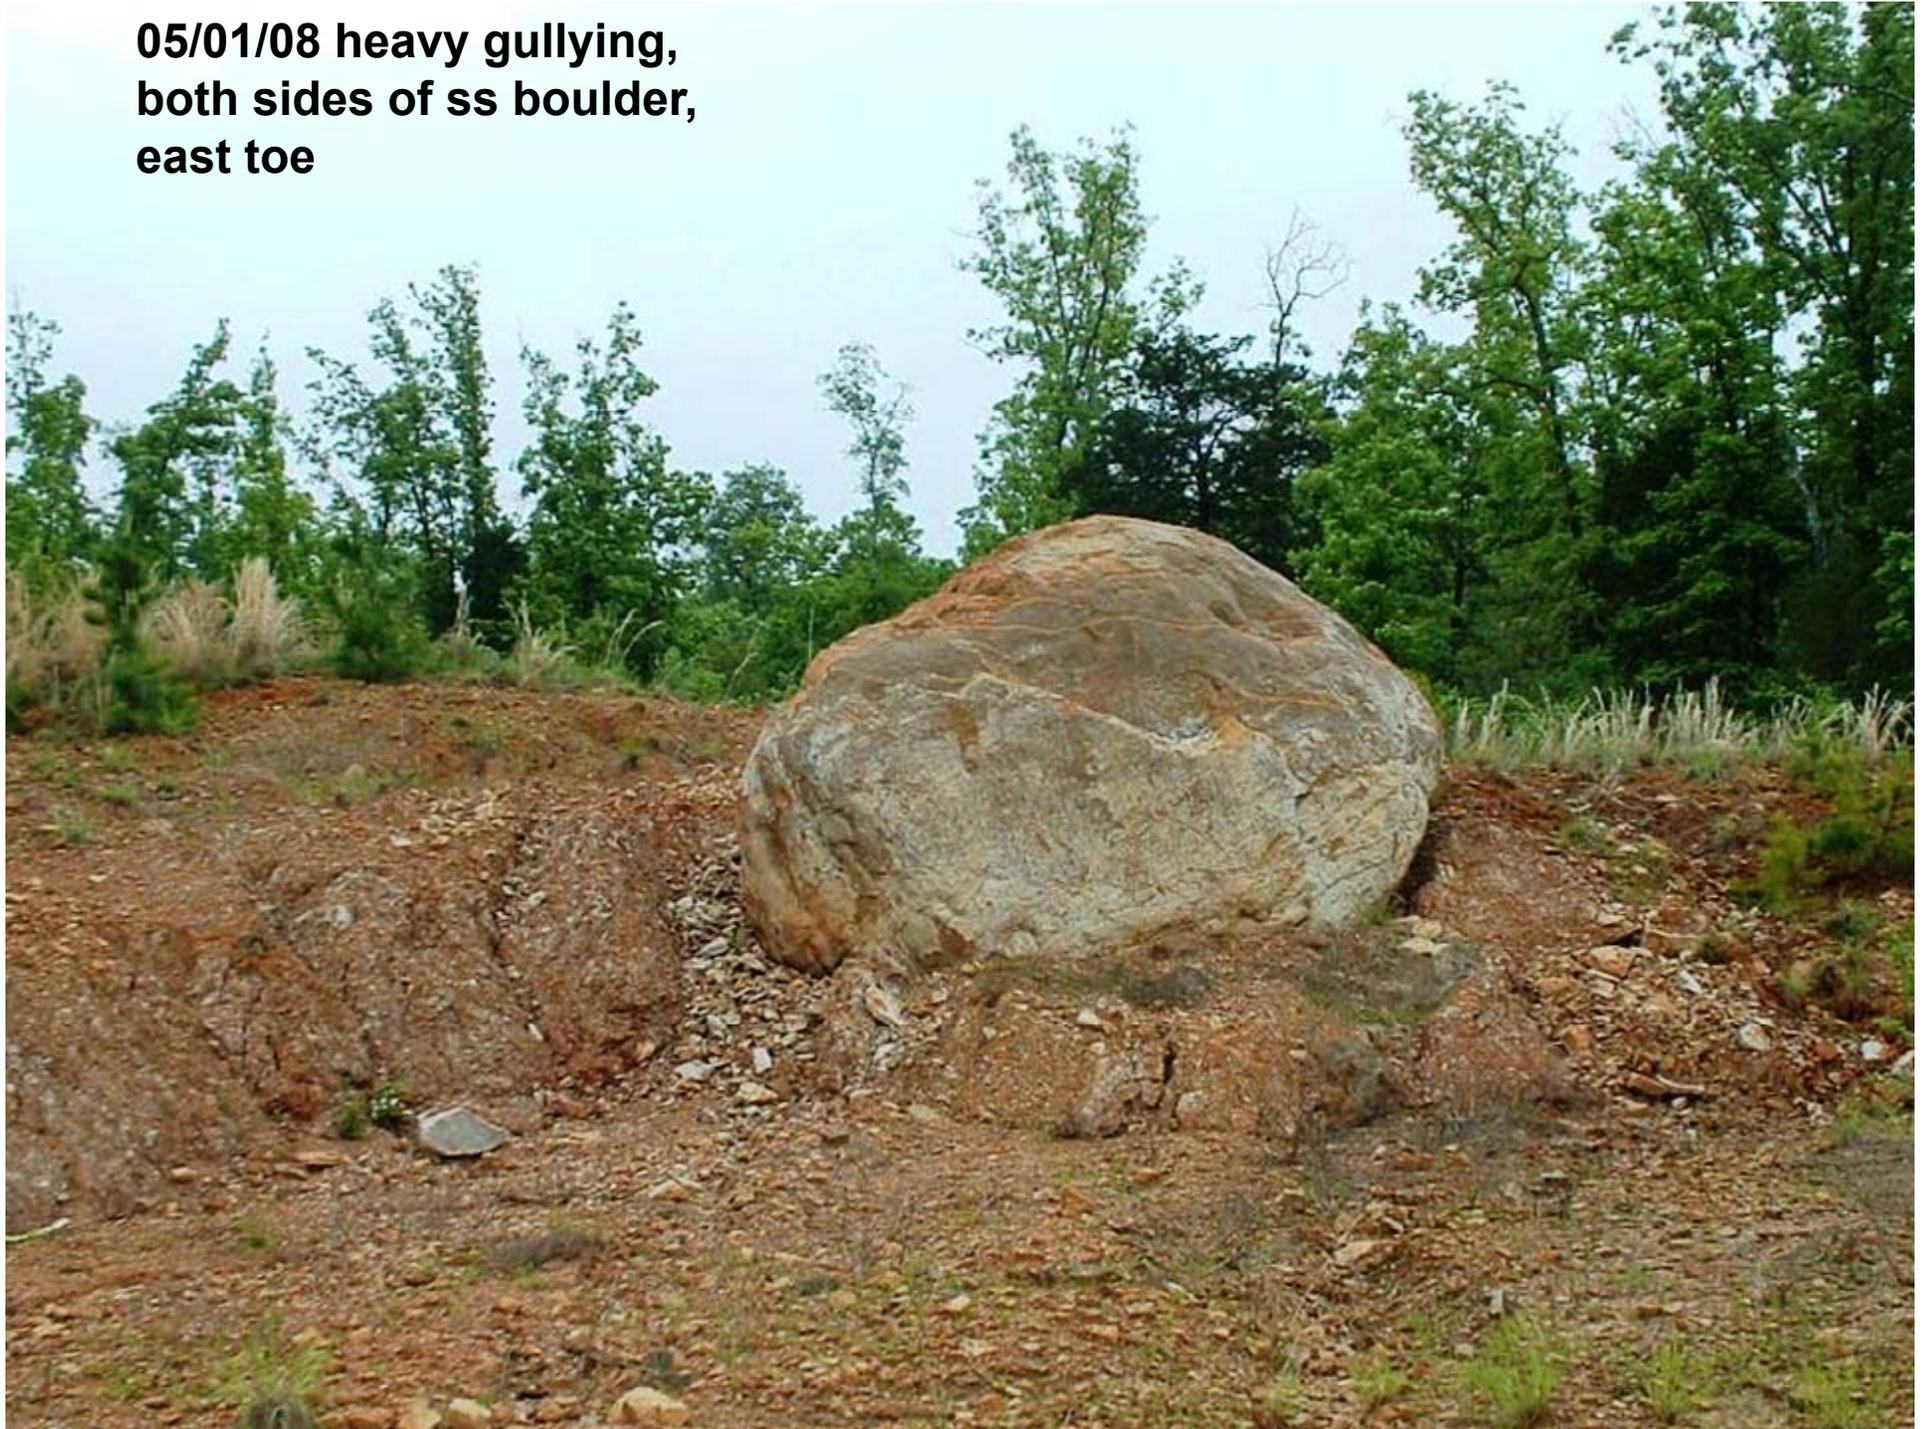
**05/01/08 heavy gullying,
both sides of ss boulder,
east toe**

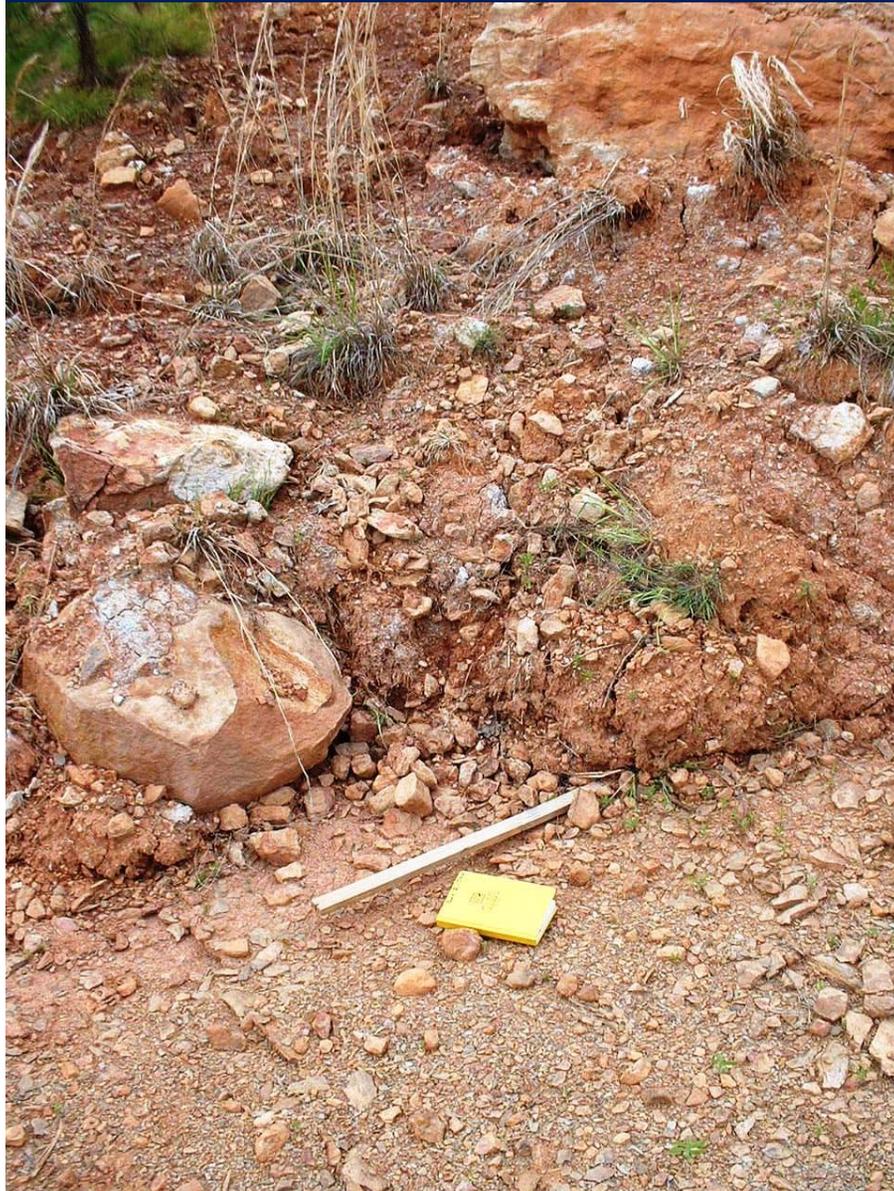
Stake 2C covered, east toe

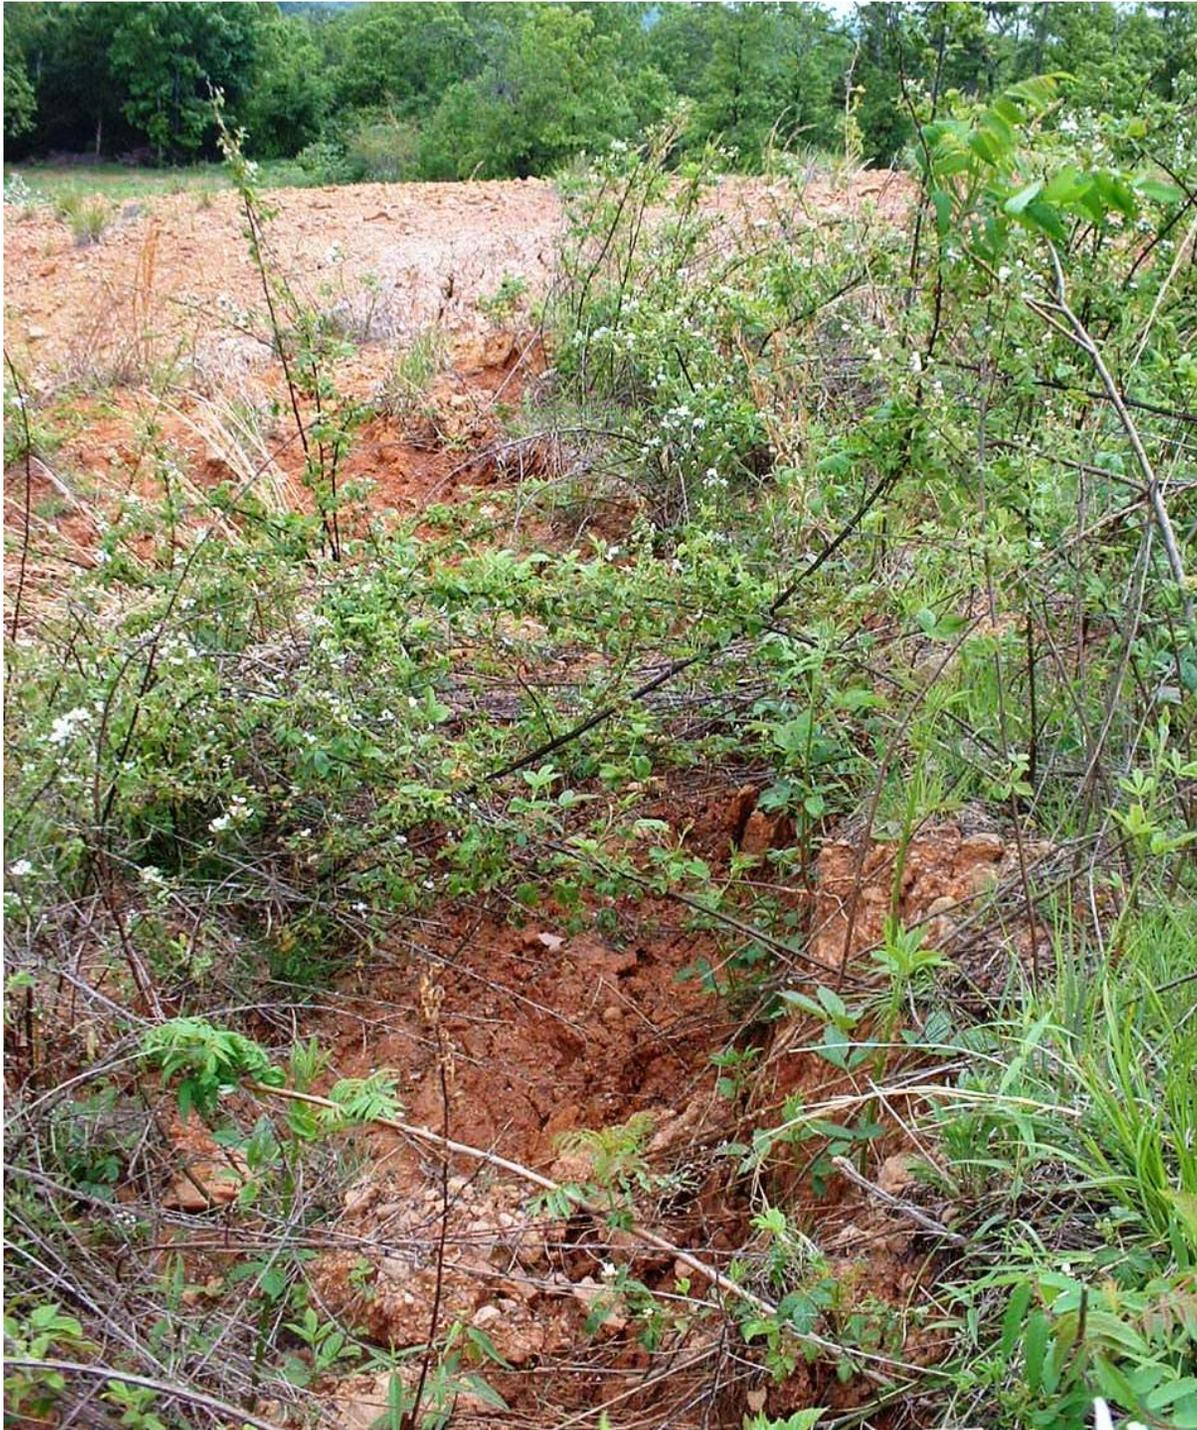
Middle toe, no stakes visible, 2 year growth pine being pushed over
