Jones Landslide, Pottsville, Arkansas – 2 ½ years of Monitoring

By
J. Michael Howard

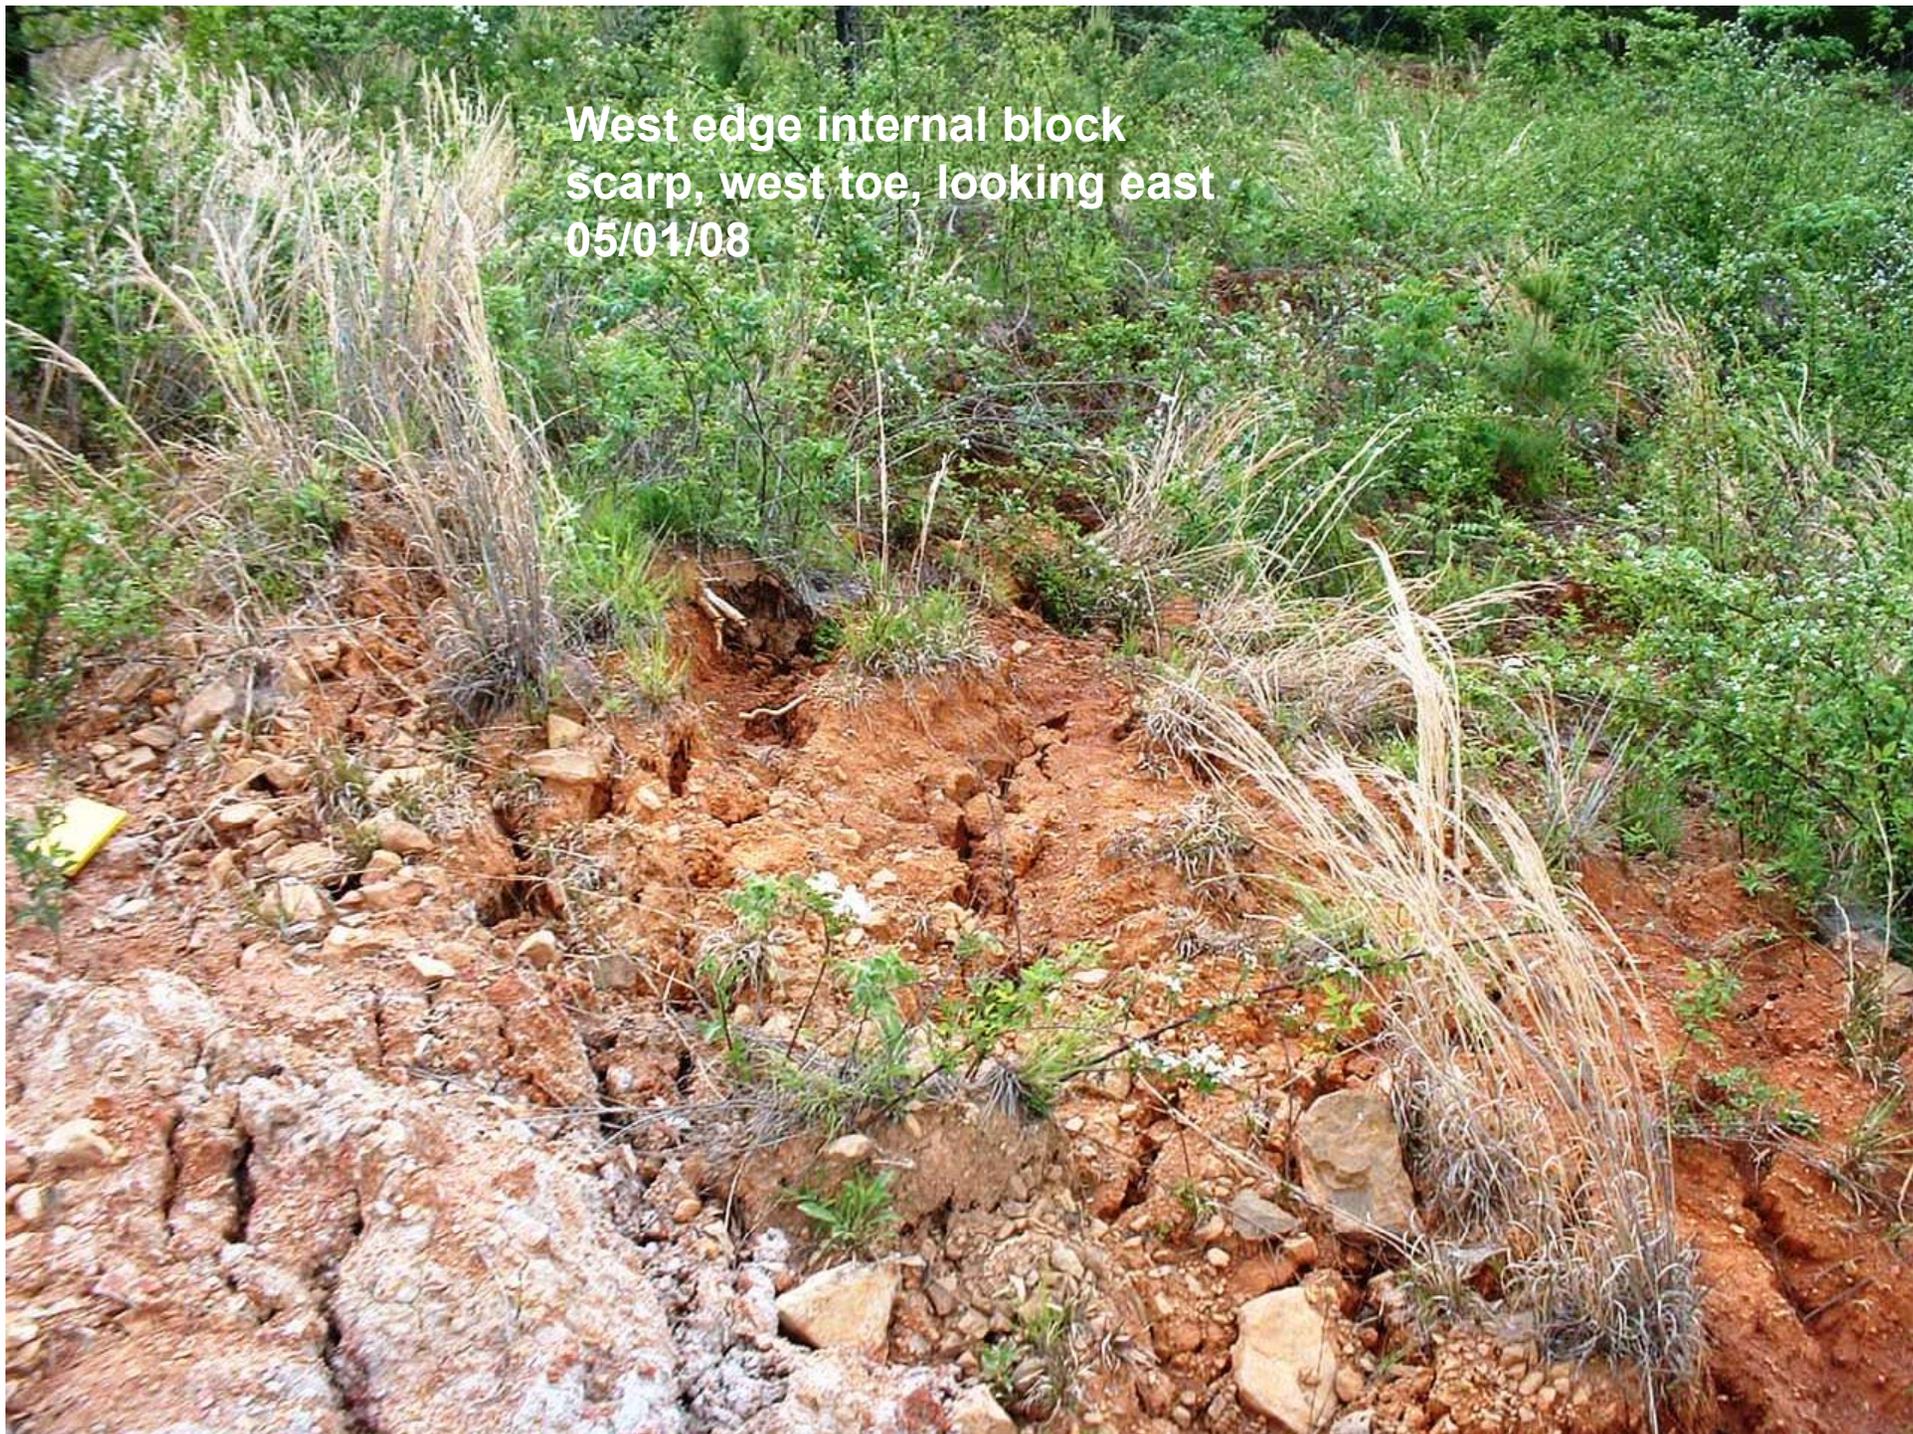
**2 feet of displacement
on internal scarp, west
toe...looking west**

West edge internal block
scarp, west toe, looking east
05/01/08

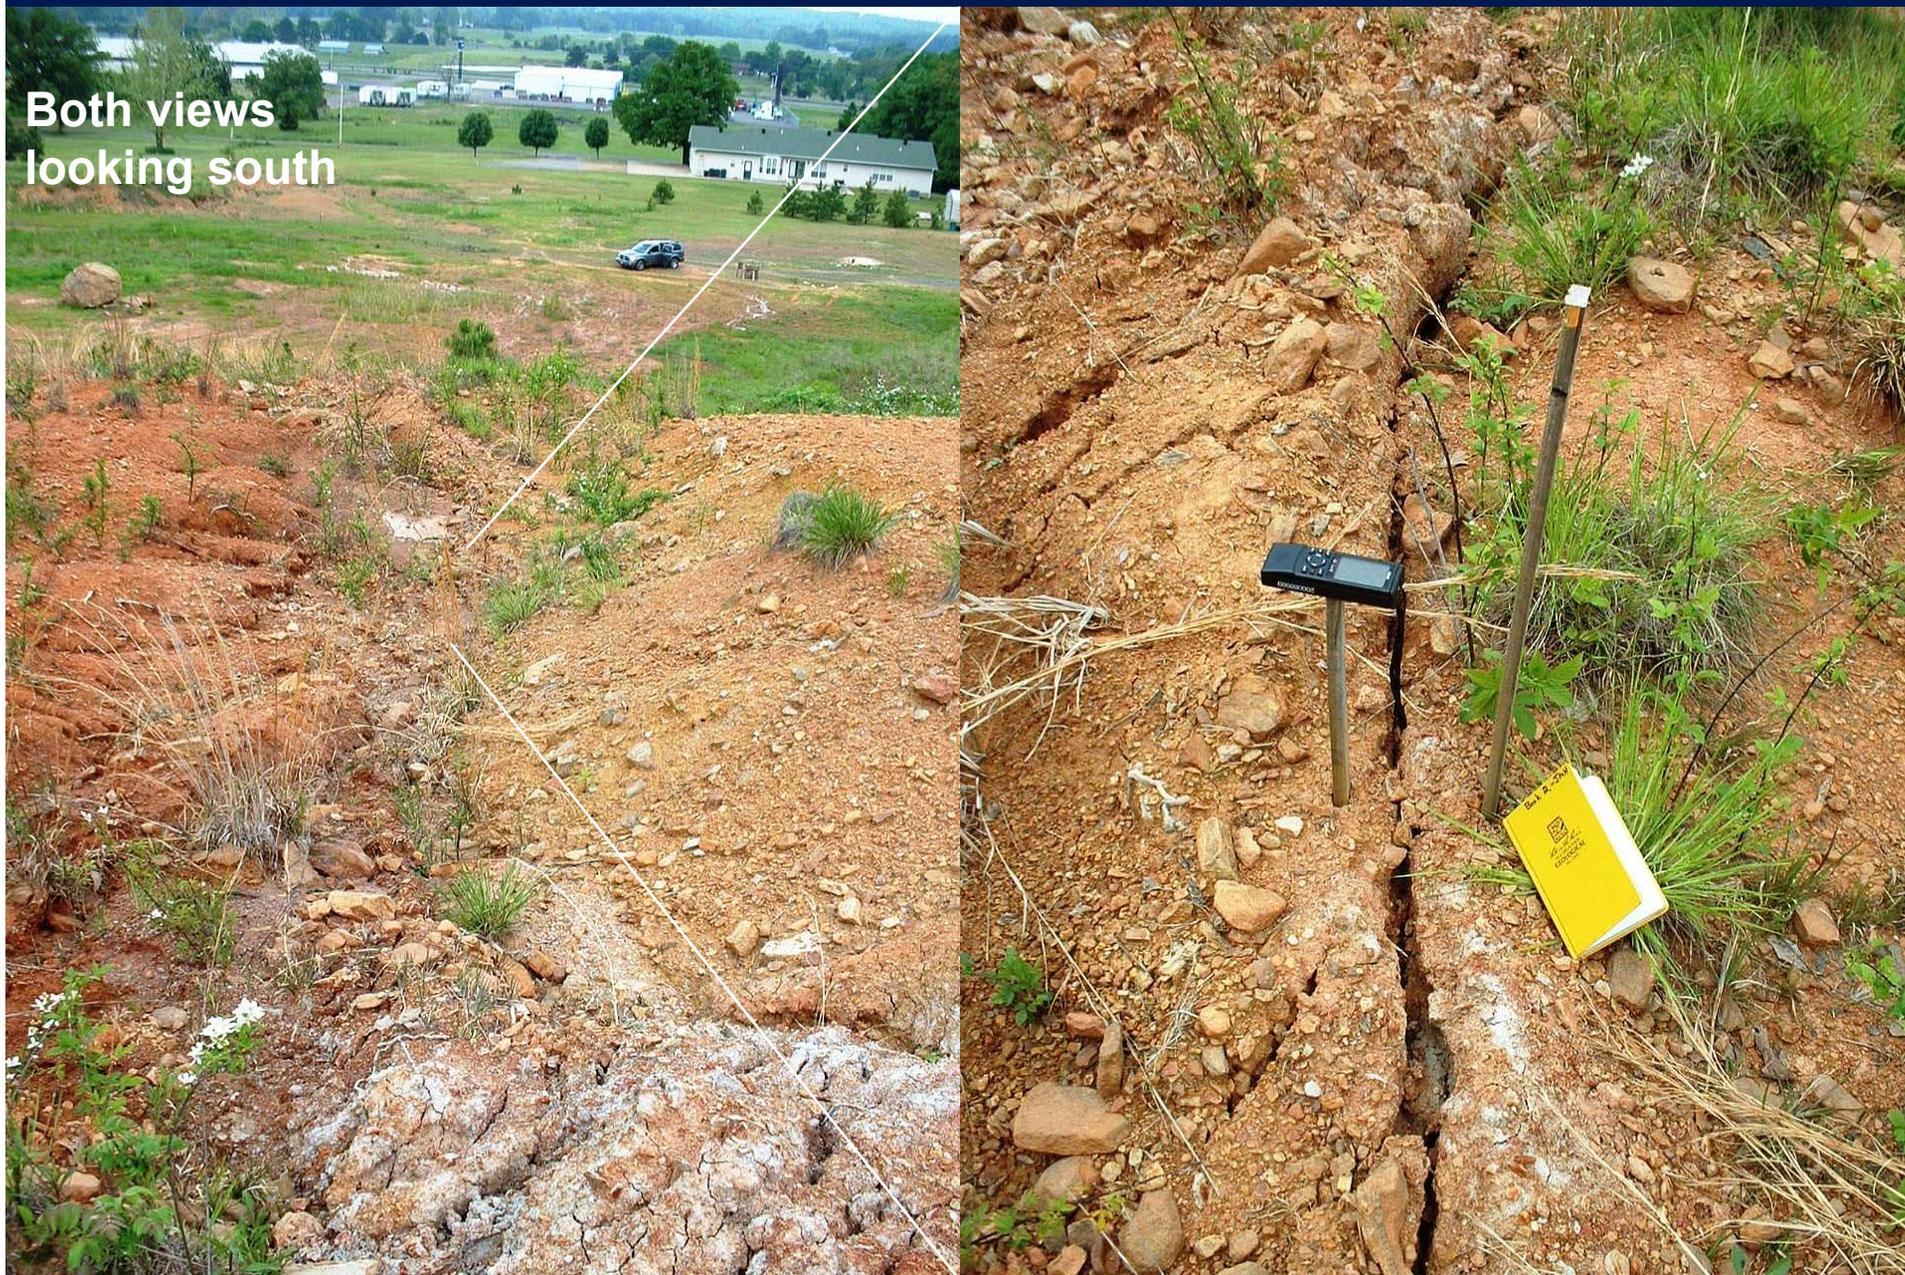
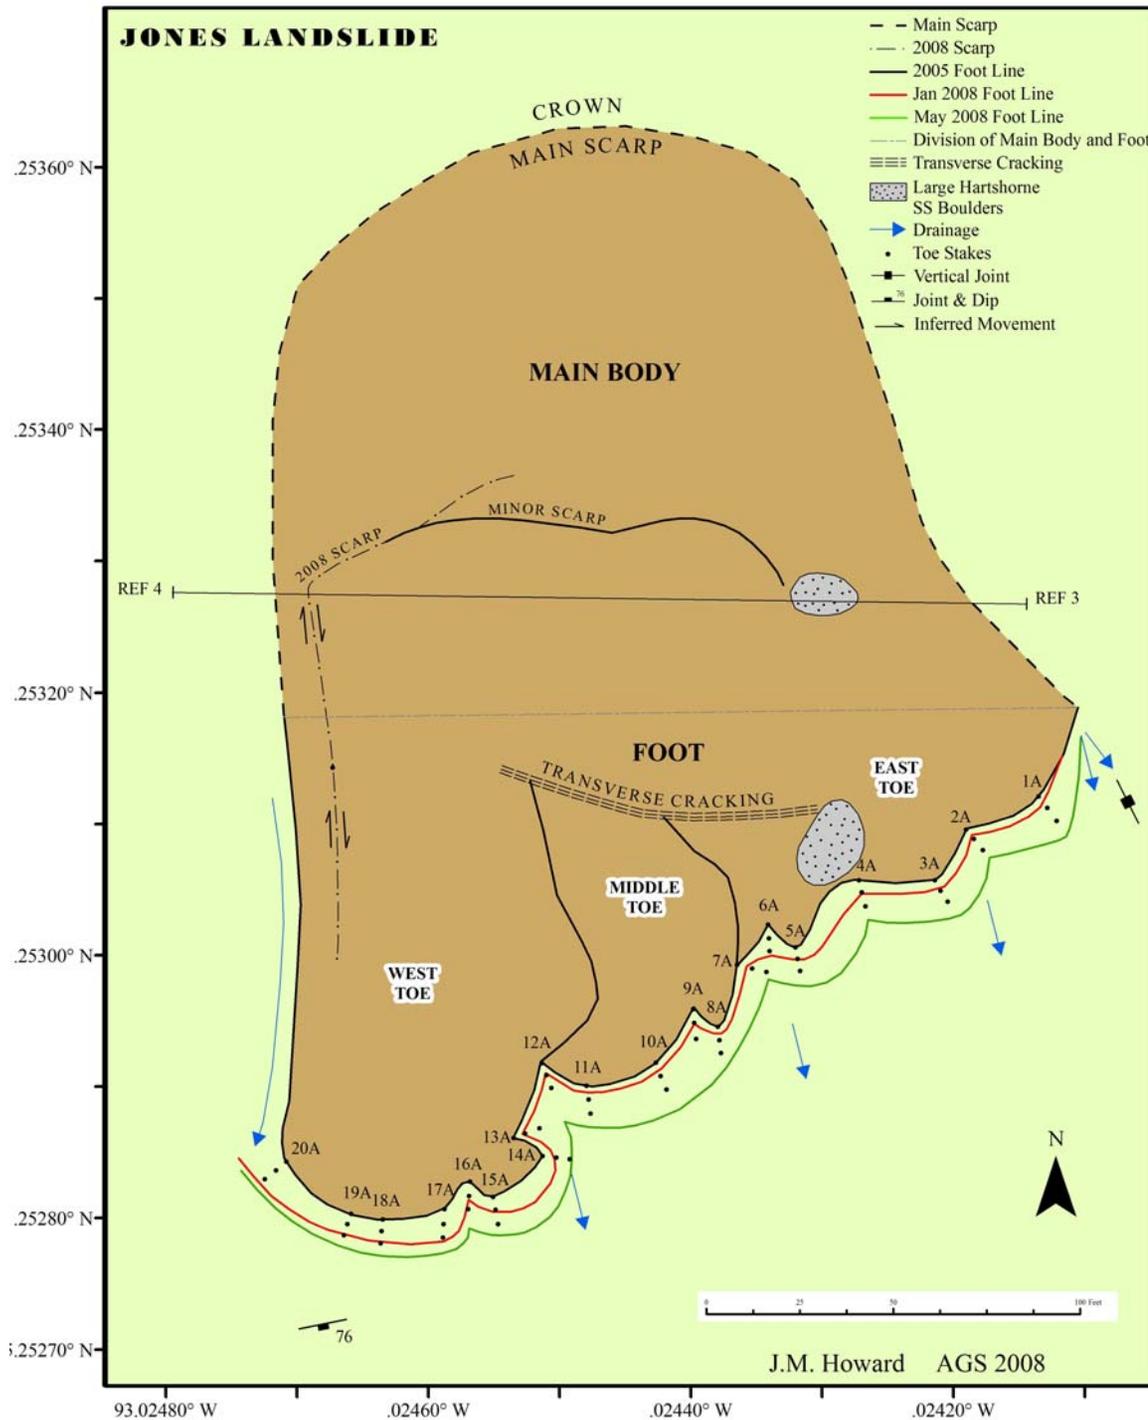
West edge new fracture

Close up with monitoring stakes in place
