## The Duck Crusher Landslide Site

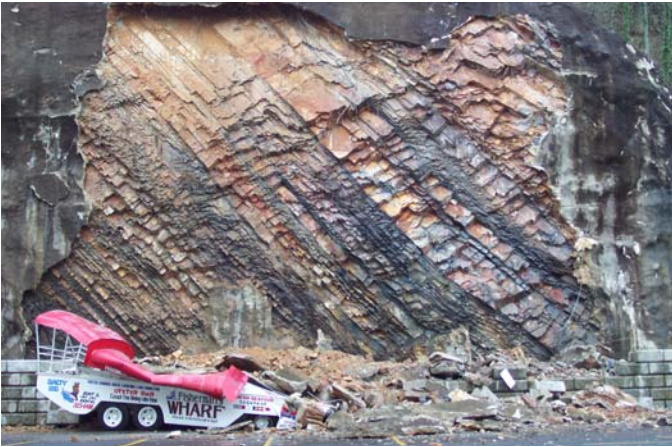
Gunnite collapse in 2005 that destroyed duck.

On the morning of January 29<sup>th</sup>, 2005, a rock fall occurred in the parking lot across the street from the Arlington Hotel (Fig 10 and 11A). Unlike other landslides in the area, this slide involved little, if any, of the natural rock outcrop. This fall was caused by the separation of gunnite (sprayed-on concrete) from the nearly vertical highwall at the back of the parking lot. In the pictures below, it can be noted that the failing gunnite was evident over a period. Fortunately, no one was injured or killed by this collapse. The gunnite was first employed in the 1950's as a means of mitigating the landslide issue. Unfortunately, the gunnite has only created a

greater problem. Gunnite seals some of the fracture and joint planes, preventing water from escaping. The trapped water will lubricate and weaken the joint planes, and can accelerate the landslide potential (McElwaine, 1966). Future rock failures are inevitable and visitors should think twice before using this parking facility.
